City of Monterey Park Wastewater Collection System Master Plan Update

City of Monterey Park

Phoenix Civil Engineering, Inc.

1/13/2014

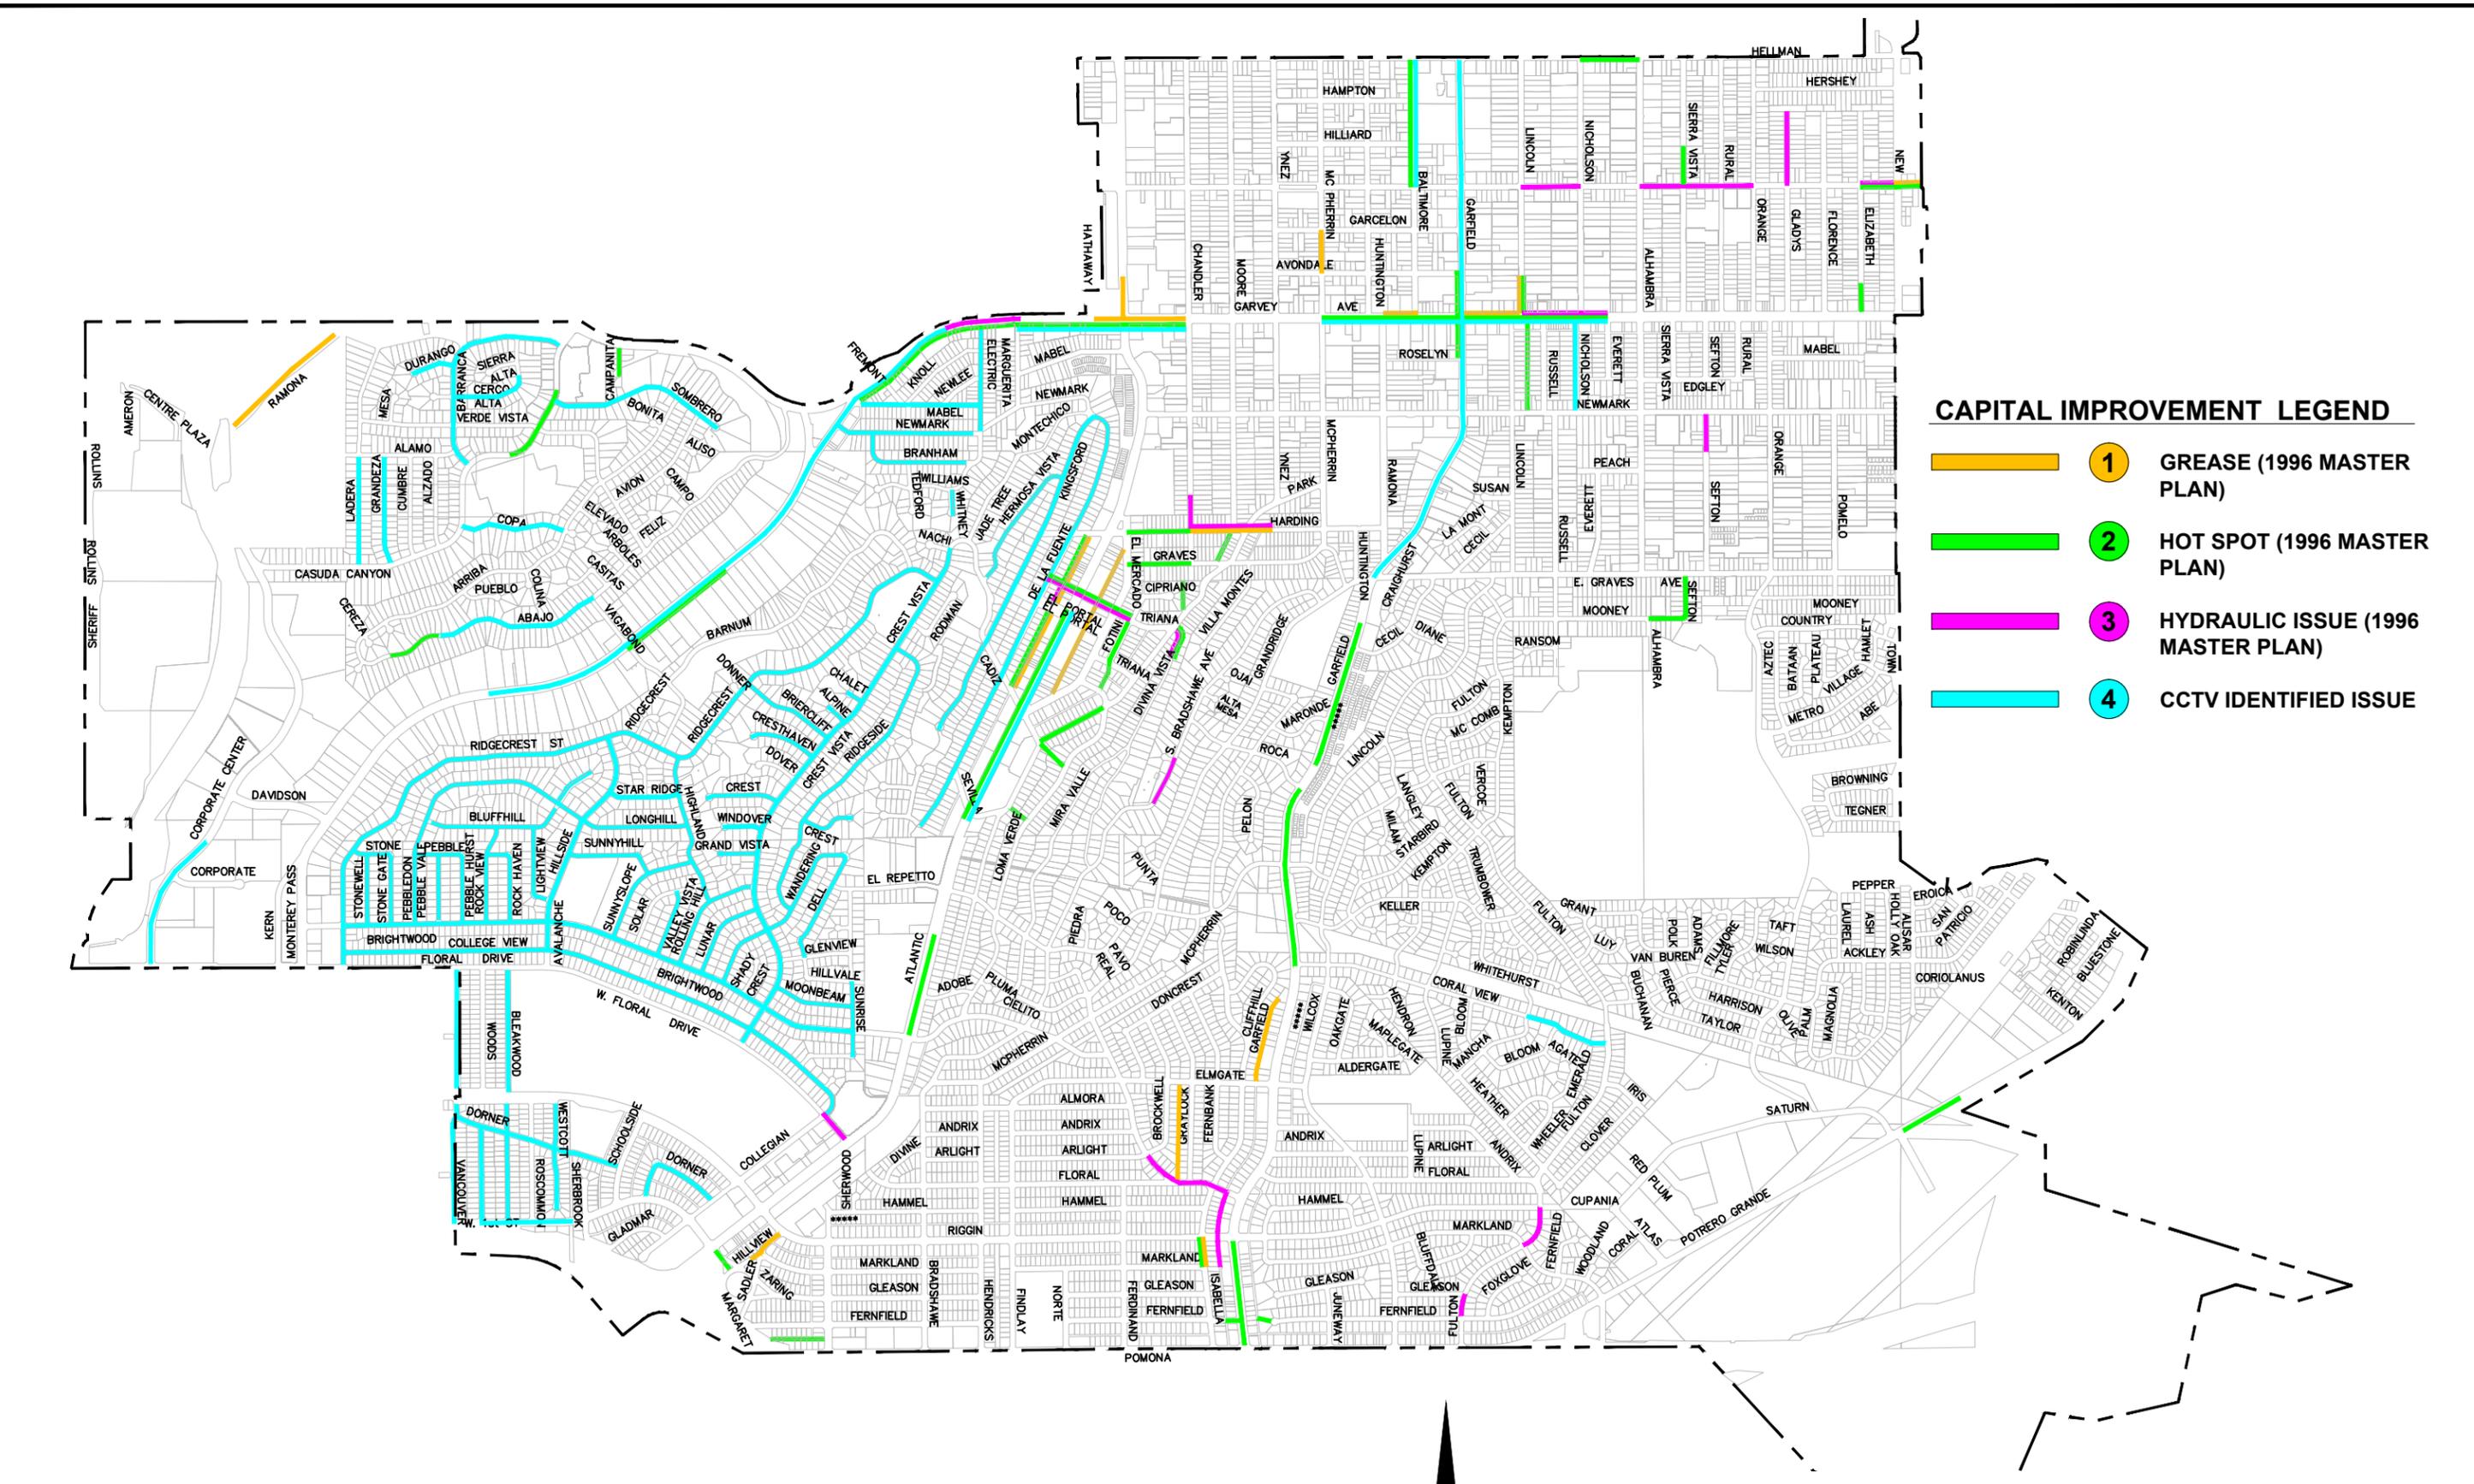
DWG: P:\Projects\MMTP061301_Waste Water Master Plan\Locales\CSD\Figures\FIGURE-4_Capital Imps Proj.dwg USER: ros
 DATE: Nov 12, 2013 11:35am XREFS: City Base Map R14 PC-Fig-BDR 11x17

CAPITAL IMPROVEMENT LEGEND

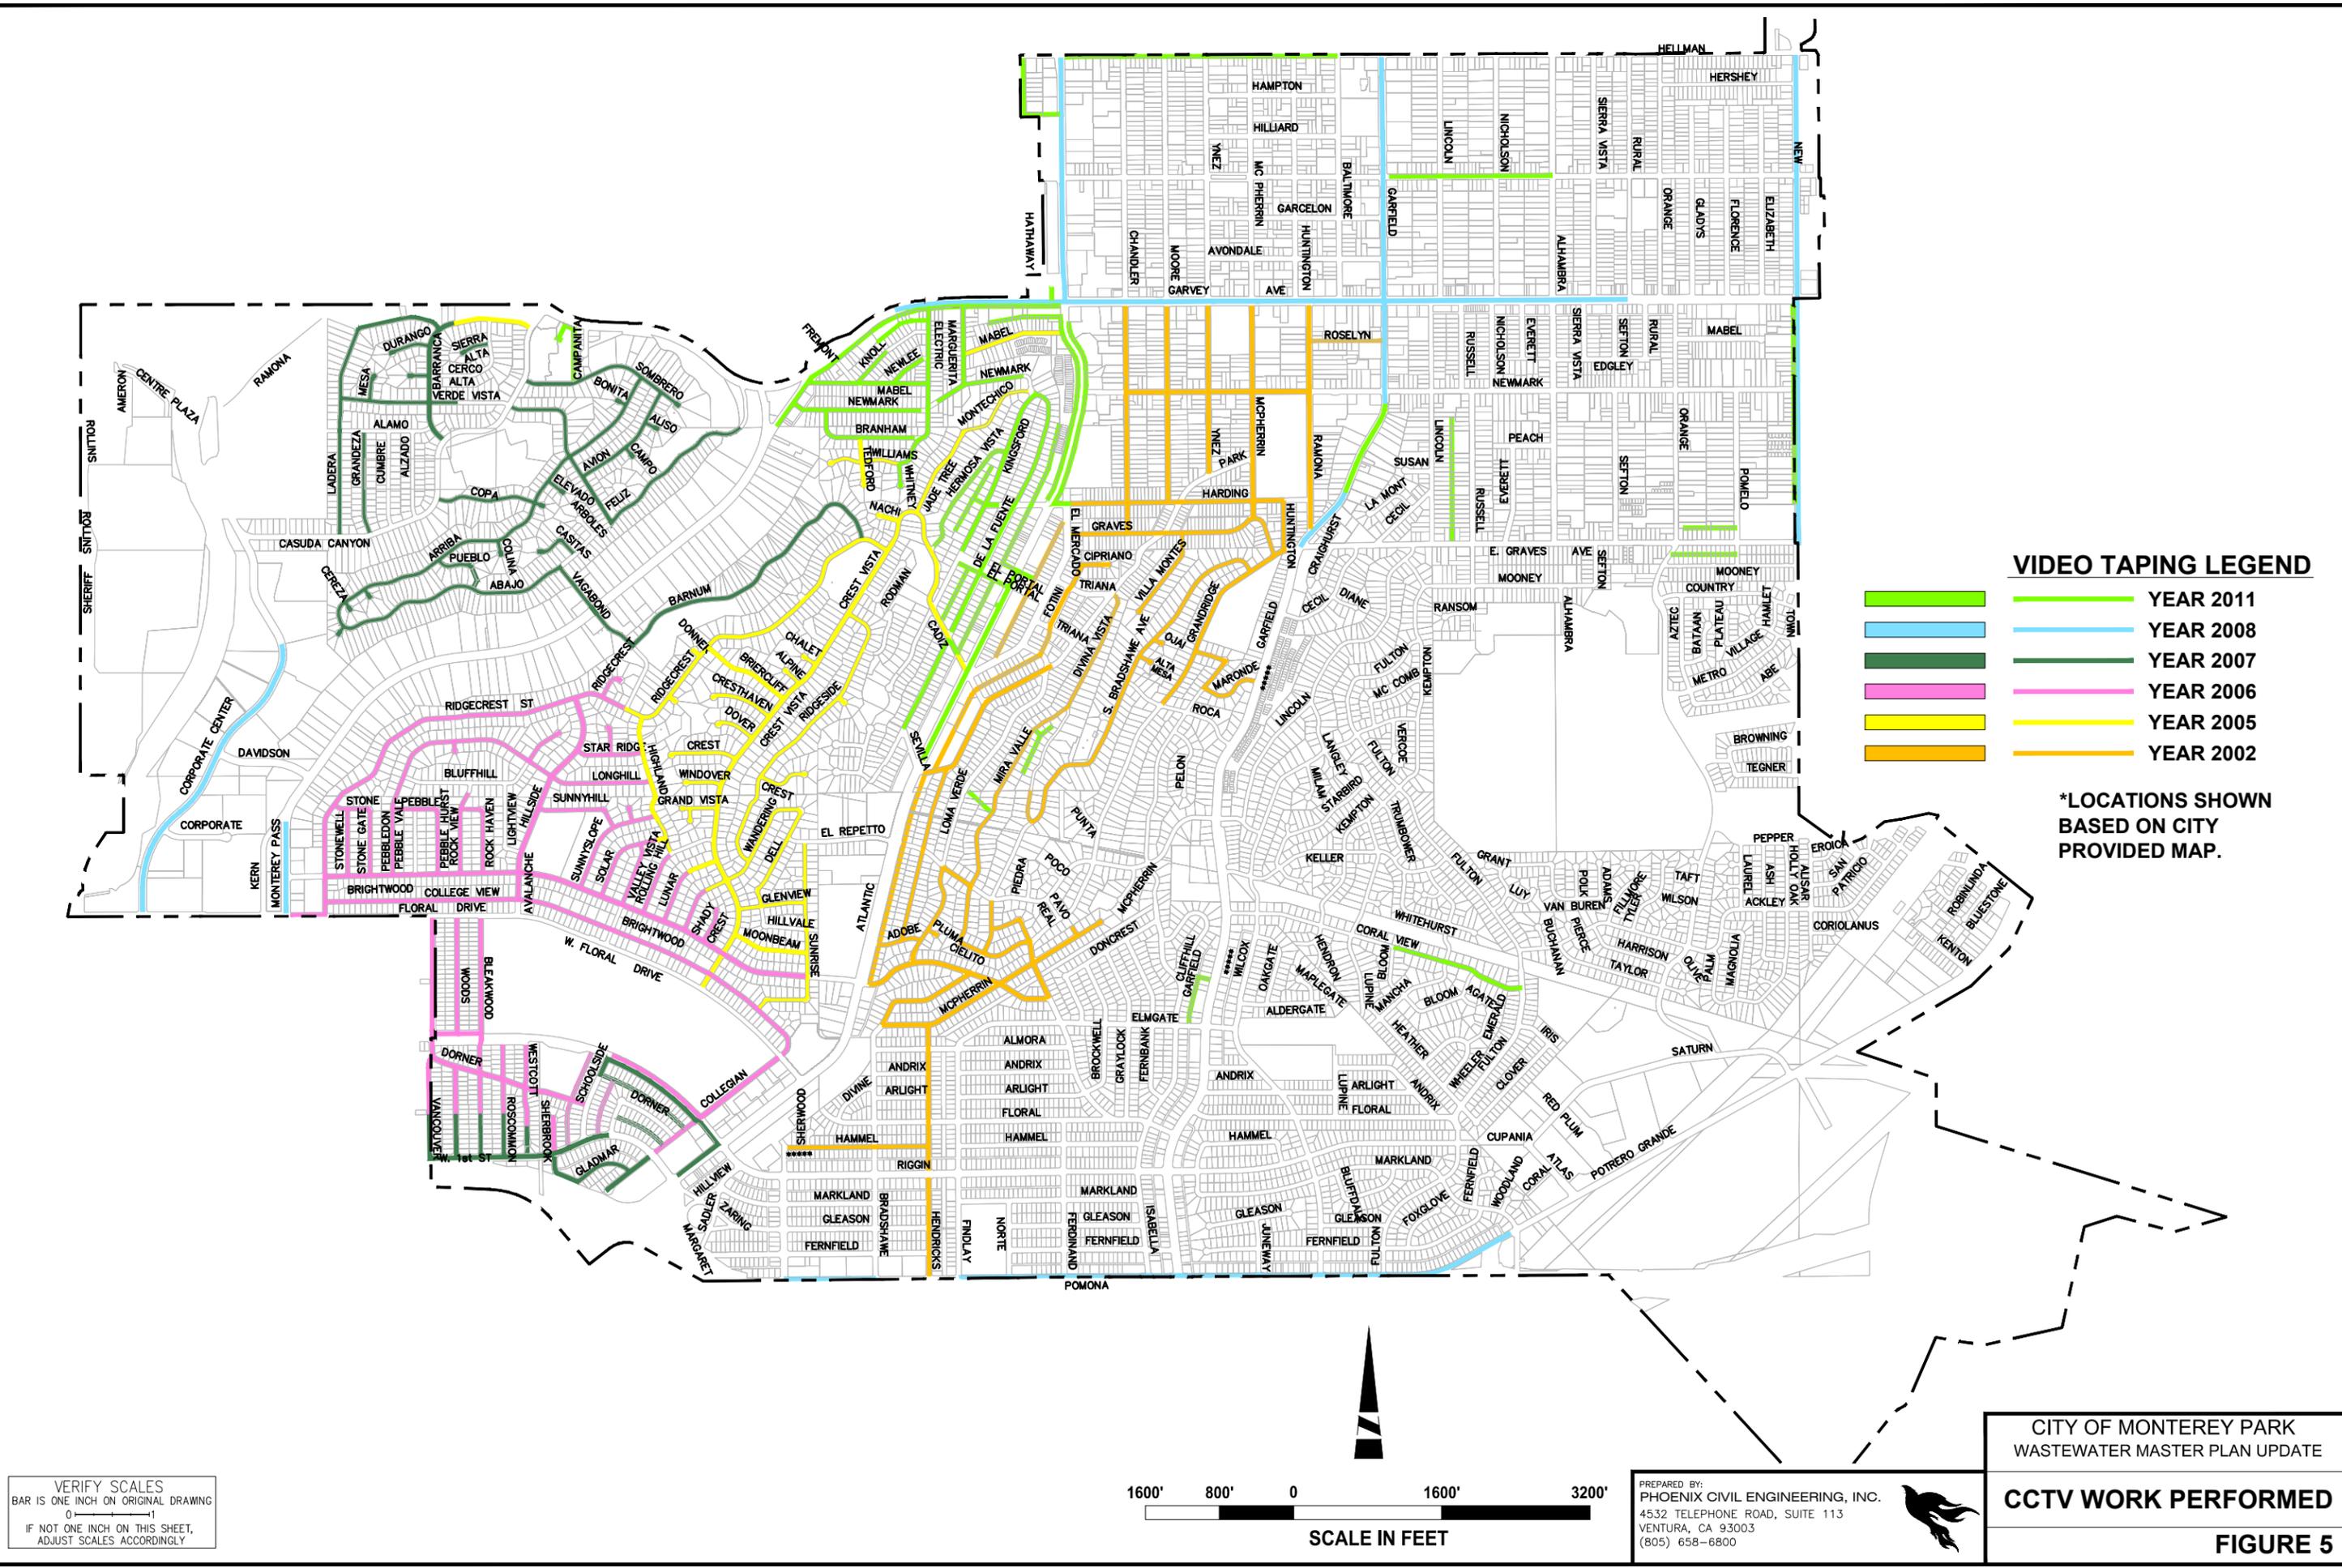
DWG: P:\Projects\MMTP061301\Waste Water Master Plan\Reports\Figures\Figure-5 CCTV.dwg
 DATE: Nov 12, 2013 8:38am
 XREFS: City Base Map R14 PC-FG-BDR PC-FG-BDR
 USER: ros

VIDEO TAPING LEGEND

YEAR 2011
	YEAR 2008
	YEAR 2007
	YEAR 2006
	YEAR 2005
	YEAR 2002

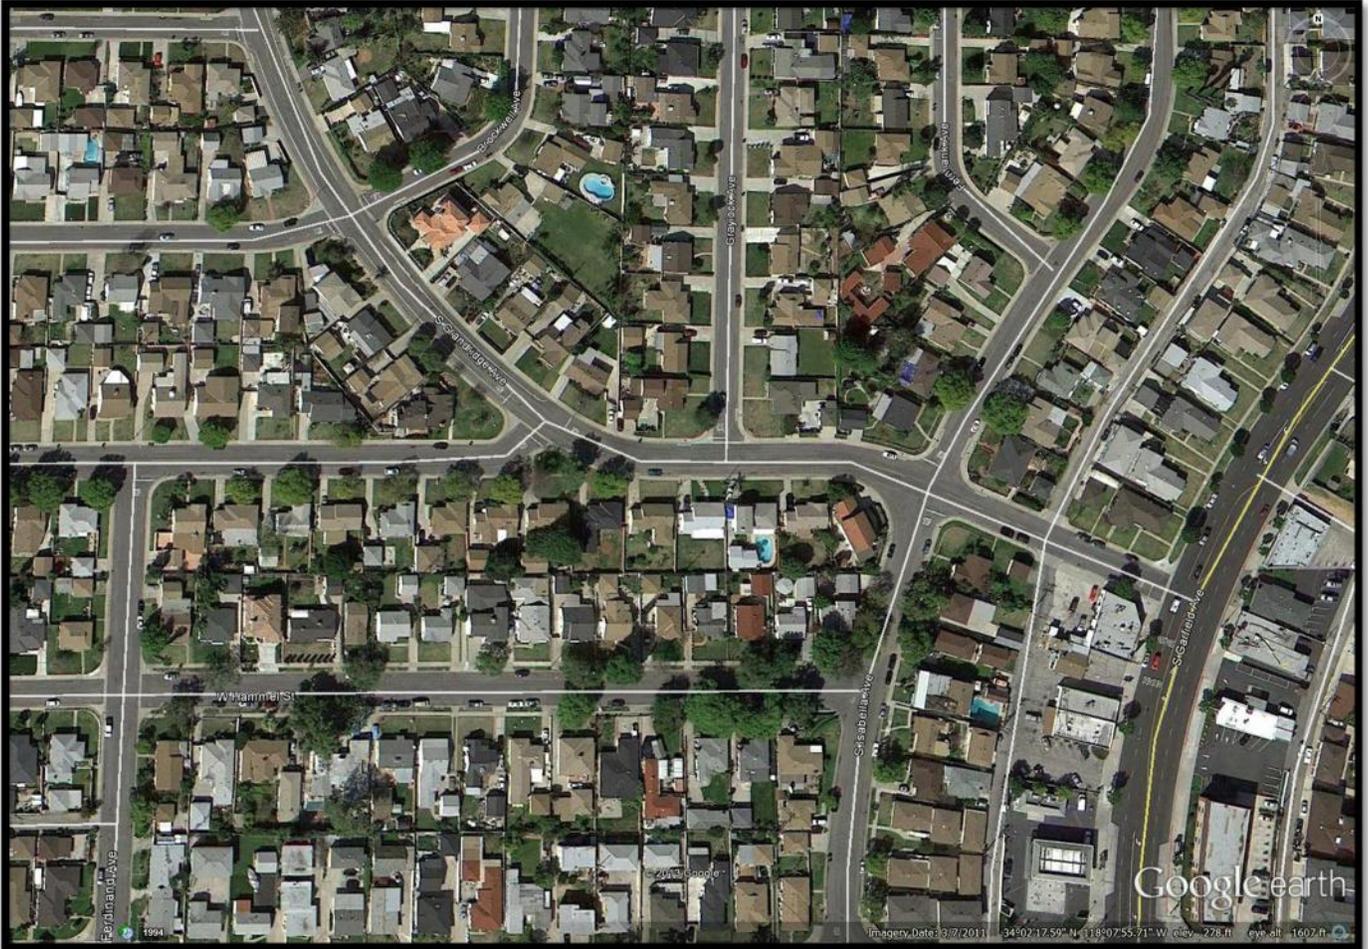
Capital Improvement Project Number	1 – 1996 Master Plan
Schedule	Year 6
Description/Location	Grandridge Ave: from Alley east of Isabella to Arlight Street
Issue	Hydraulic Deficiency
Budget	\$333,600
➤ Design	\$55,600
➤ Construction	\$278,000

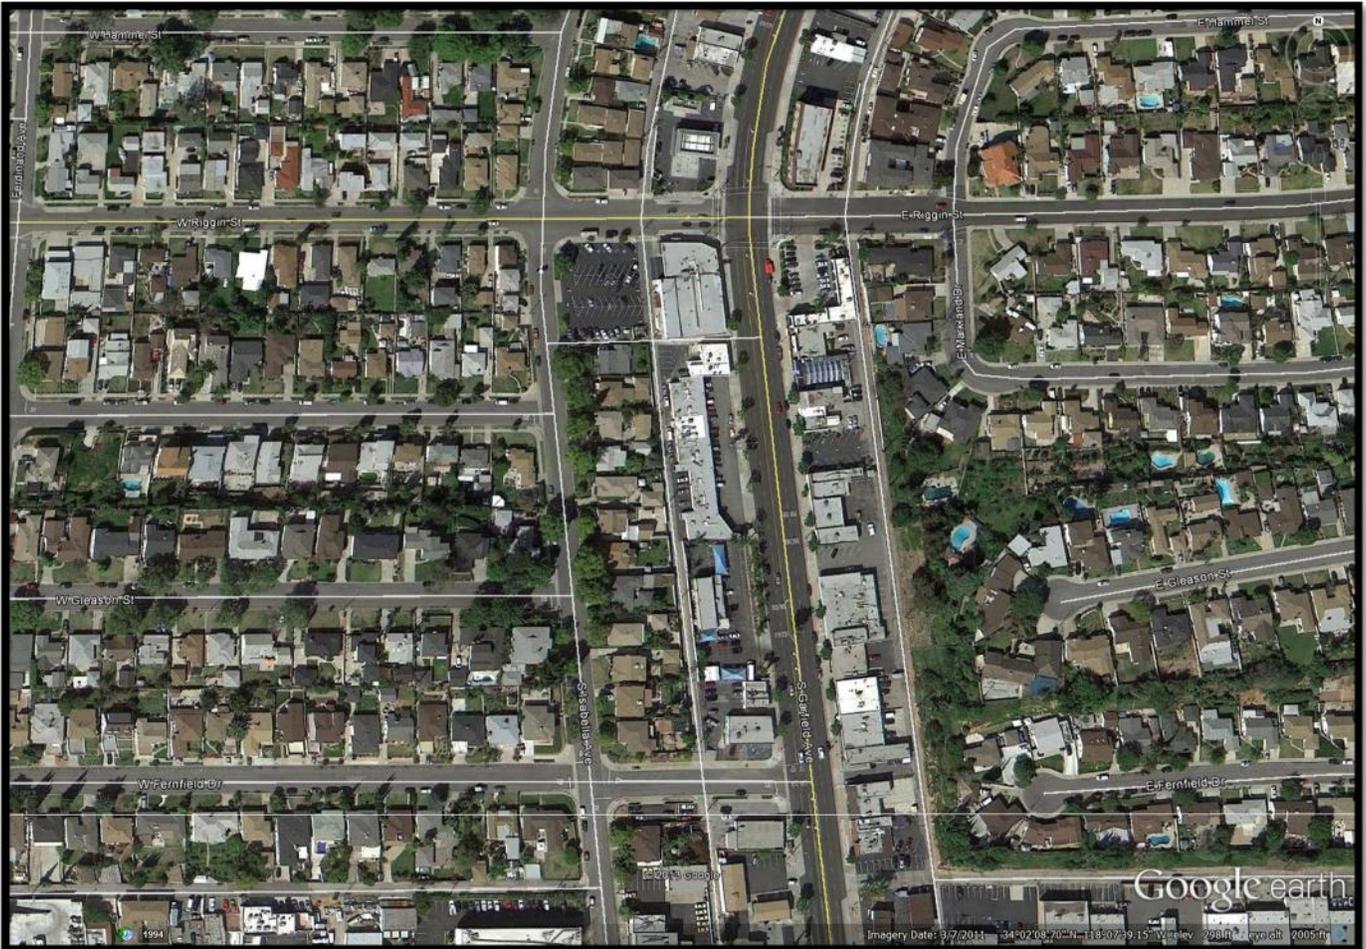
Capital Improvement Project Number	2 – 1996 Master Plan
Schedule	Year 10
Description/Location	Alley East of Isabella Ave: from Markland Dr. to Floral Dr.
Issue	Hydraulic Deficiency
Budget	\$283,300
➤ Design	\$47,200
➤ Construction	\$236,100

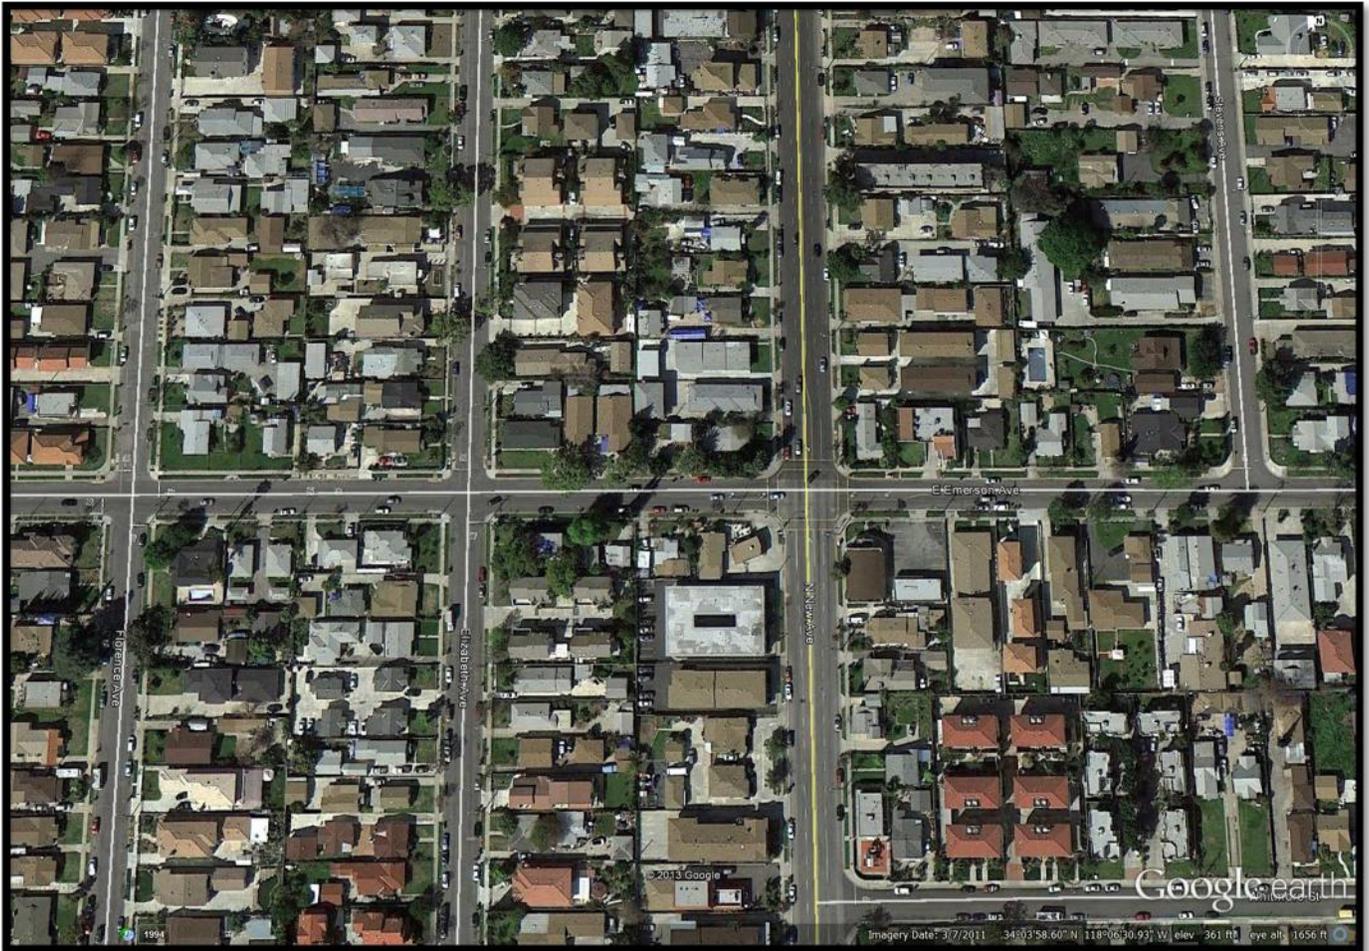
Capital Improvement Project Number	4 – 1996 Master Plan
Schedule	Year 8
Description/Location	Emerson Ave: from New Ave. to Elizabeth Ave. and from Orange Ave. to Alhambra Ave.
Issue	Hydraulic Deficiency
Budget	\$474,000
➤ Design	\$79,000
➤ Construction	\$395,000

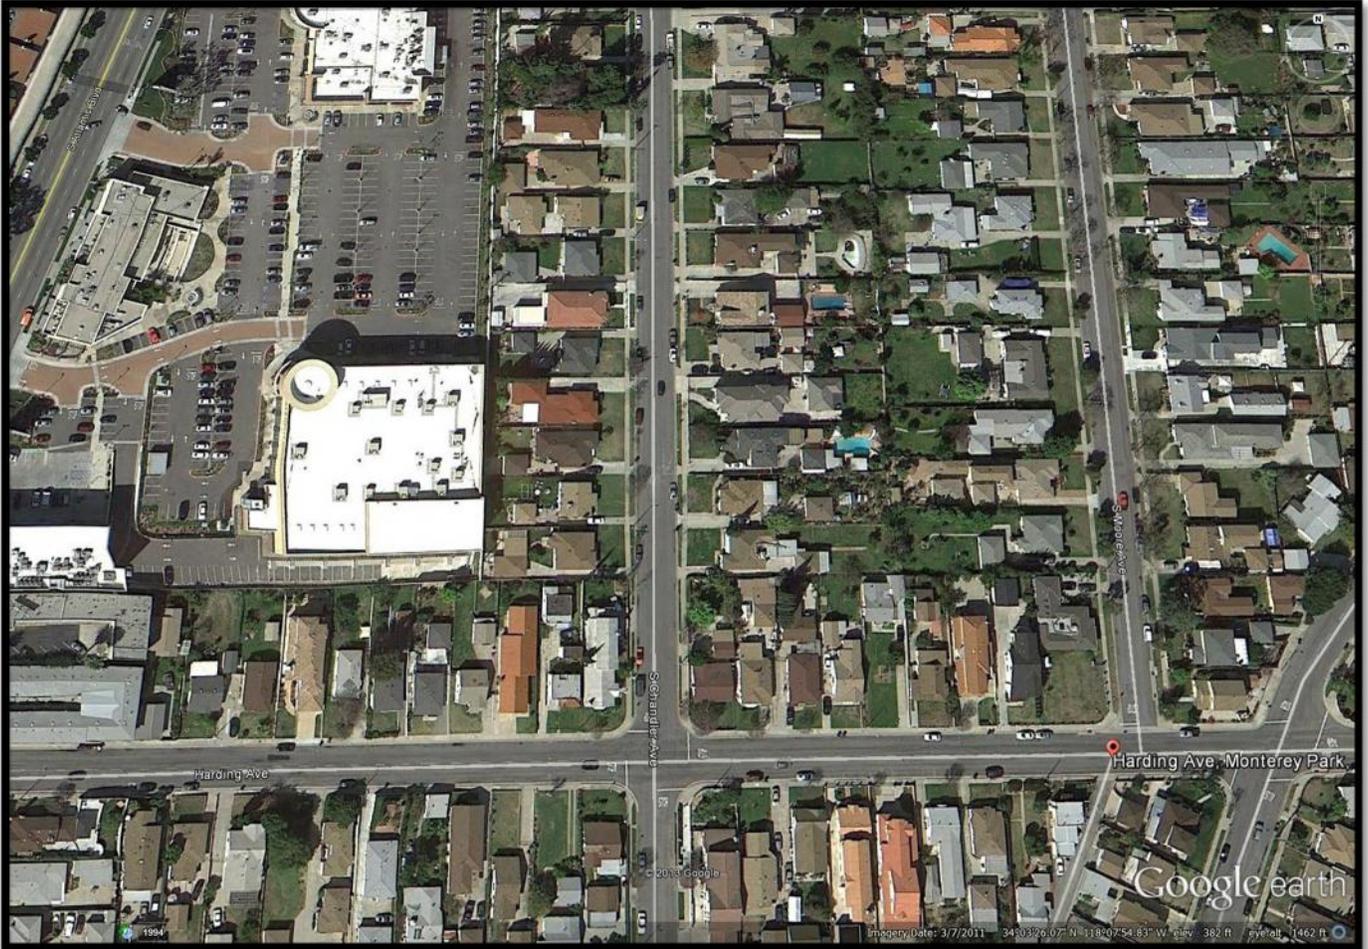
Capital Improvement Project Number	5 – 1996 Master Plan
Schedule	Year 7
Description/Location	Chandler Ave: from Harding Ave. to 300 ft north
Issue	Hydraulic Deficiency
Budget	\$115,600
➤ Design	\$19,300
➤ Construction	\$96,300

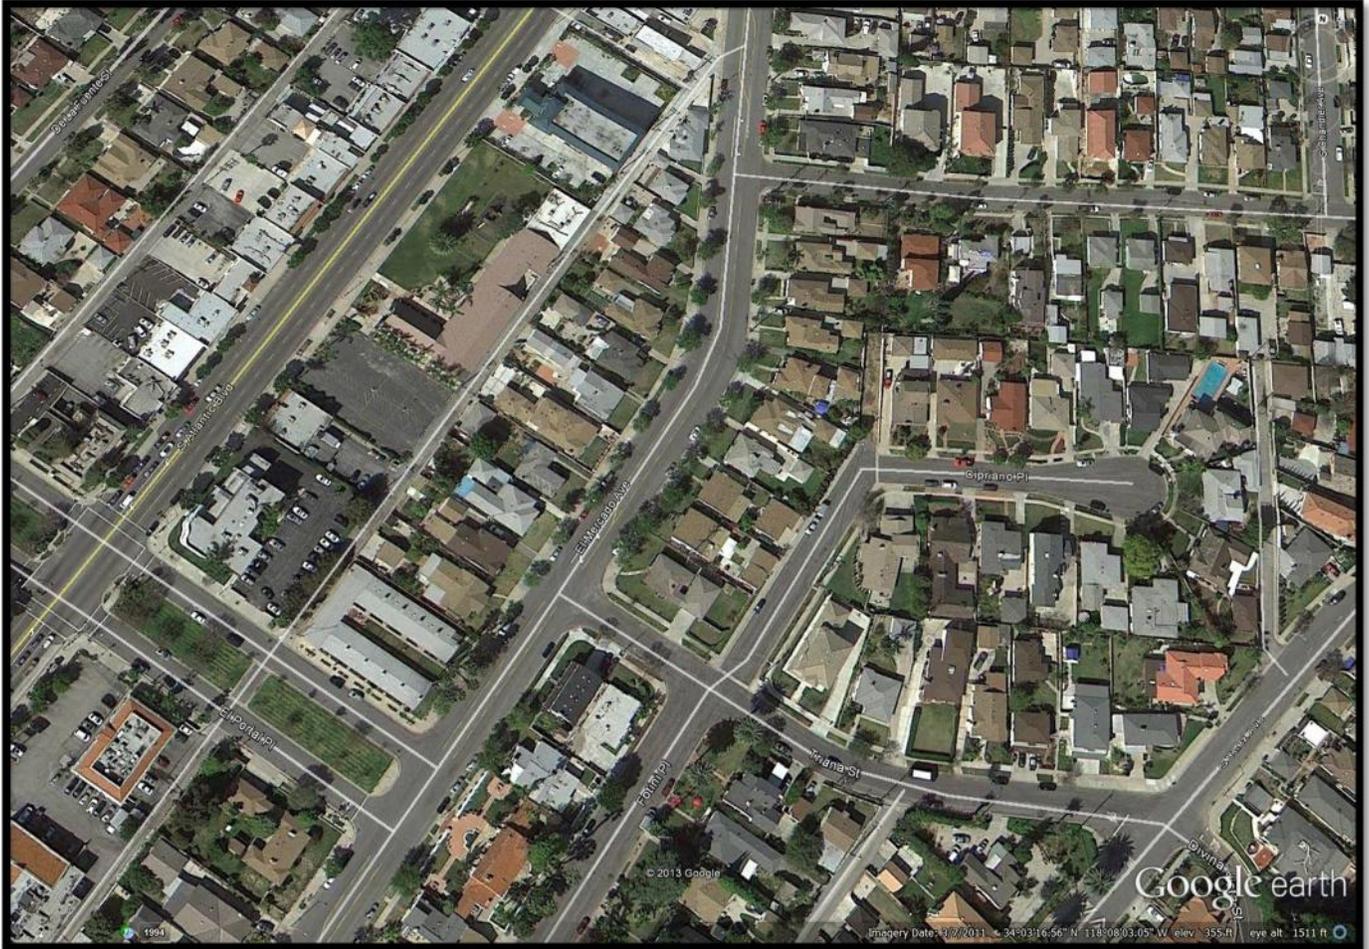
Capital Improvement Project Number	6 – 1996 Master Plan
Schedule	Year 8
Description/Location	Easement: from Cipriano Pl. to Alley west of El Mercado Ave. and Alley from easement to El Portal Ave.
Issue	Hydraulic Deficiency
Budget	\$247,900
➤ Design	\$41,300
➤ Construction	\$206,600

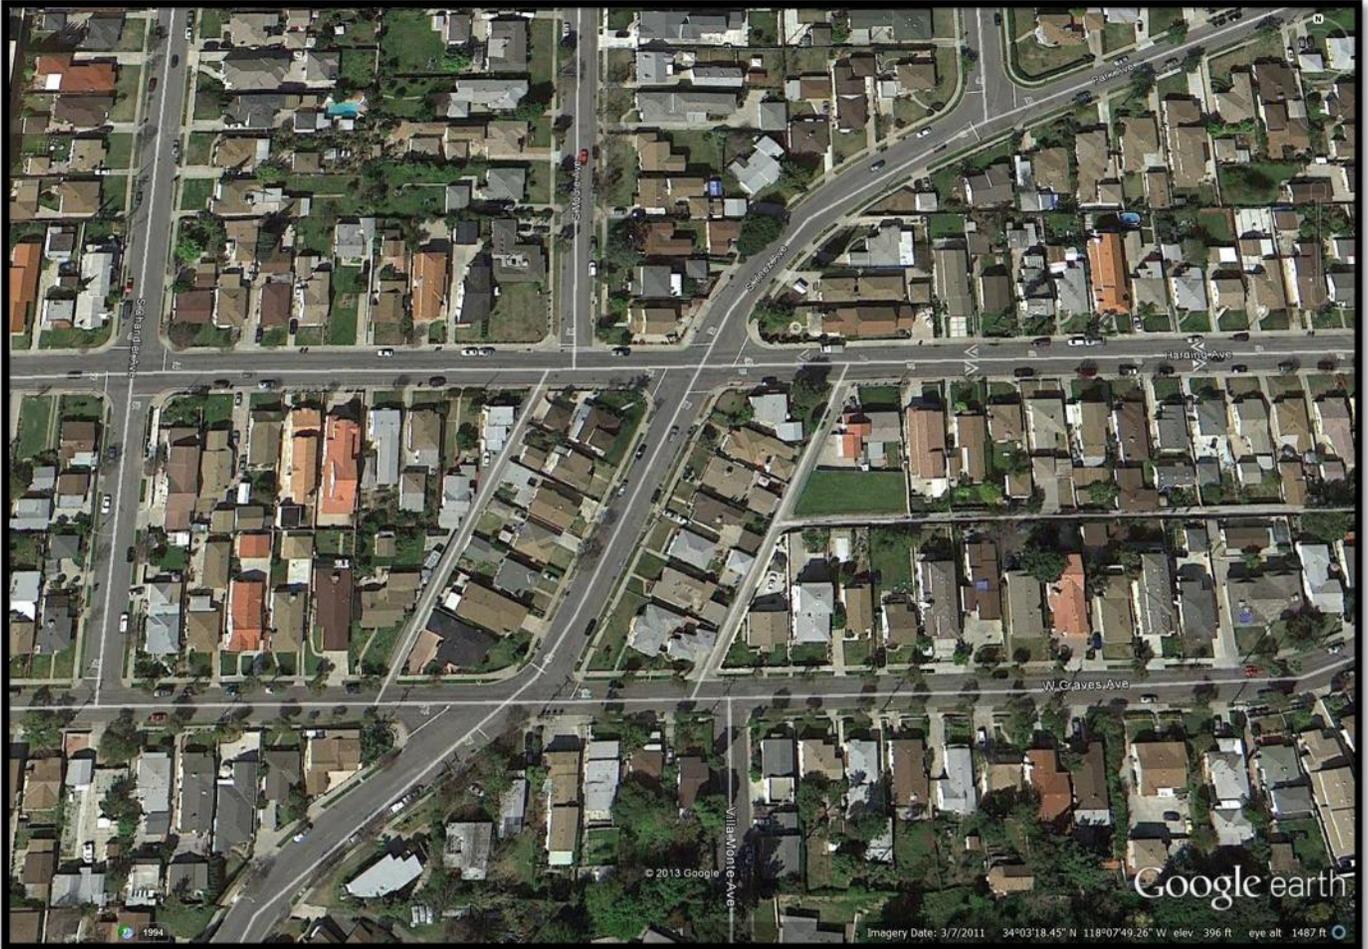
Capital Improvement Project Number	7 - 1996 Master Plan
Schedule	Year 9
Description/Location	Easement/Alley: from Harding Ave. to Ynez Ave.
Issue	Hydraulic Deficiency
Budget	\$783,000
➤ Design	\$130,500
➤ Construction	\$652,500

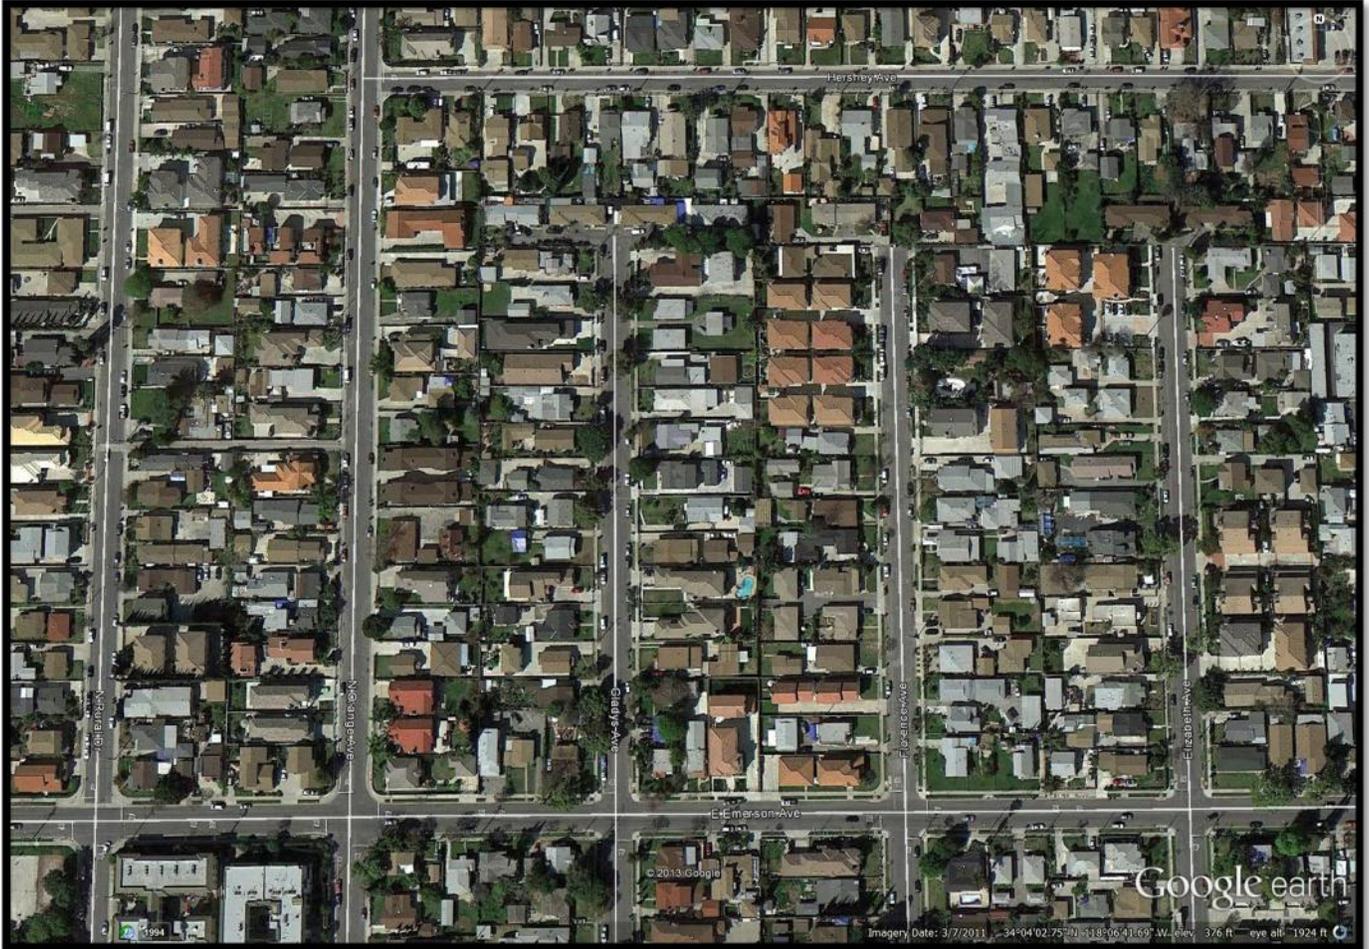
Capital Improvement Project Number	8 – 1996 Master Plan
Schedule	Year 5
Description/Location	Gladys Ave: from Emerson Ave. to end of street
Issue	Hydraulic Deficiency
Budget	\$228,400
➤ Design	\$38,100
➤ Construction	\$190,300

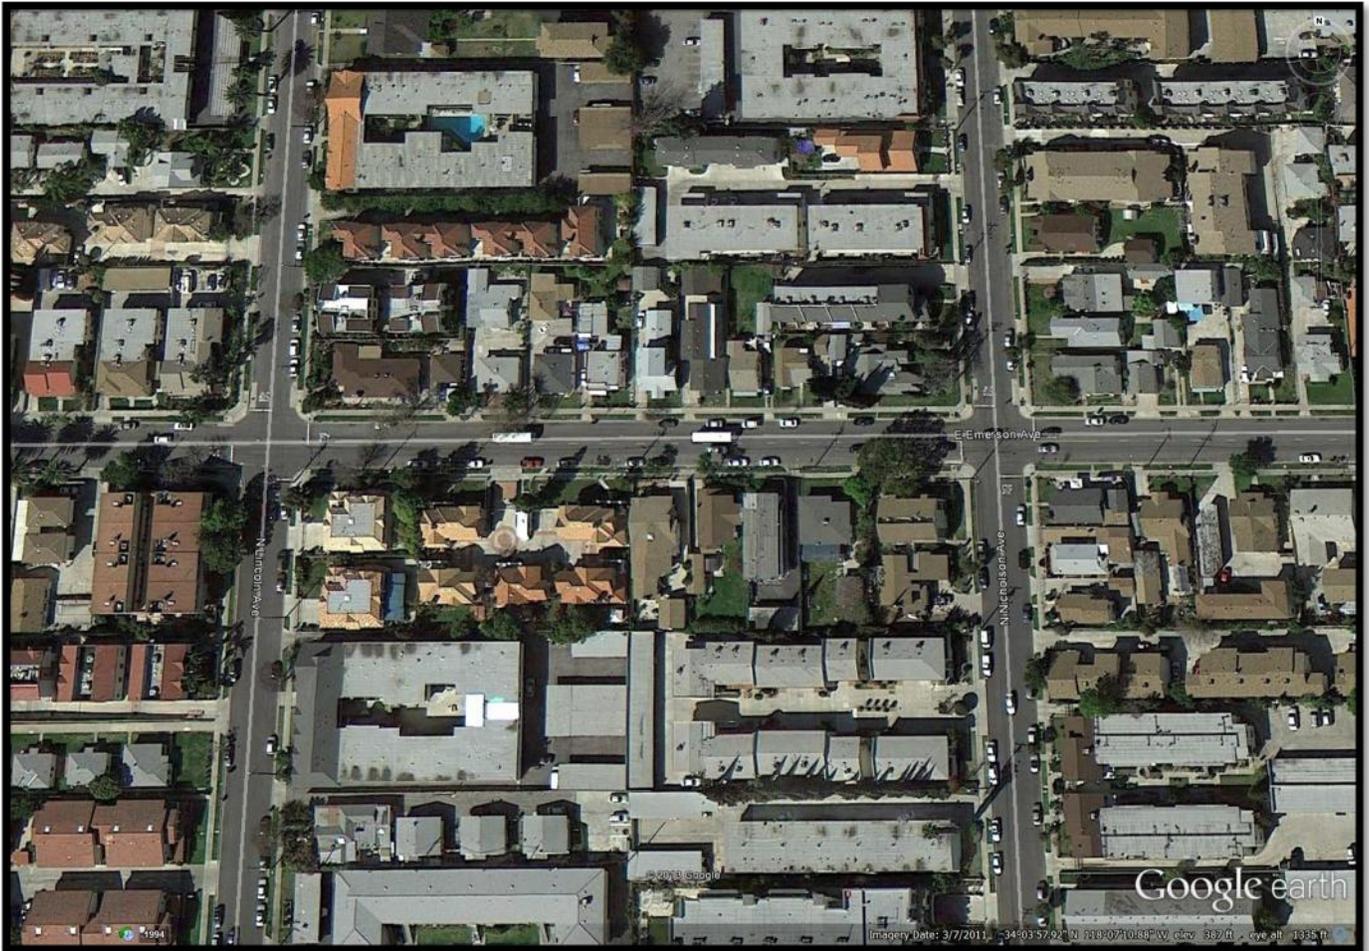
Capital Improvement Project Number	9 – 1996 Master Plan
Schedule	Year 8
Description/Location	Emerson Ave: from Nicholson Ave. to Lincoln Ave.
Issue	Hydraulic Deficiency
Budget	\$176,800
➤ Design	\$29,500
➤ Construction	\$147,300

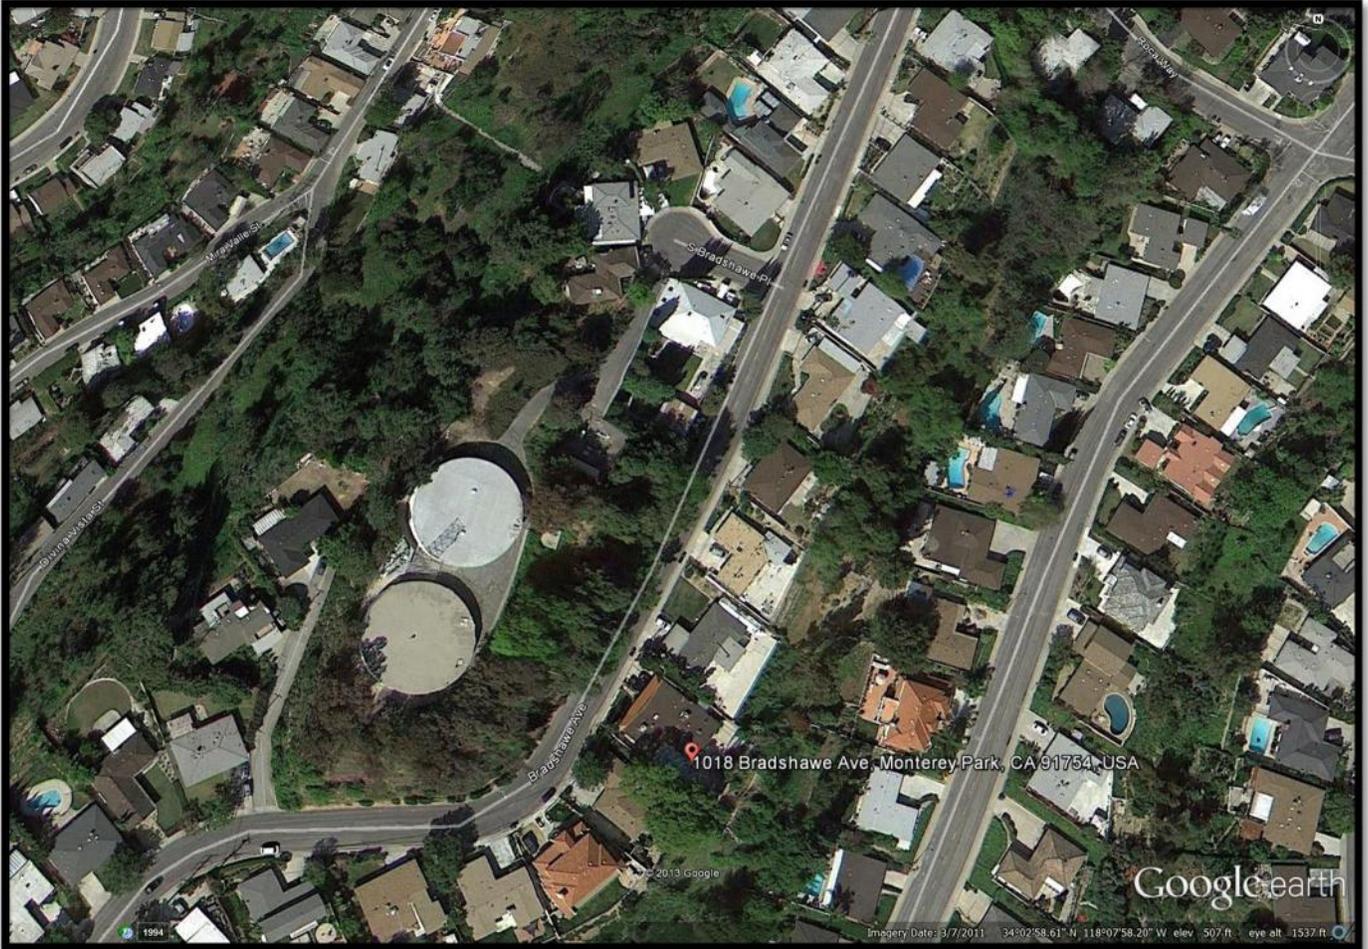
Capital Improvement Project Number	10 – 1996 Master Plan
Schedule	Year 8
Description/Location	Bradshaw Ave: from 1018 Bradshaw Ave. to Bradshaw Pl.
Issue	Hydraulic Deficiency
Budget	\$84,400
➤ Design	\$14,100
➤ Construction	\$70,300

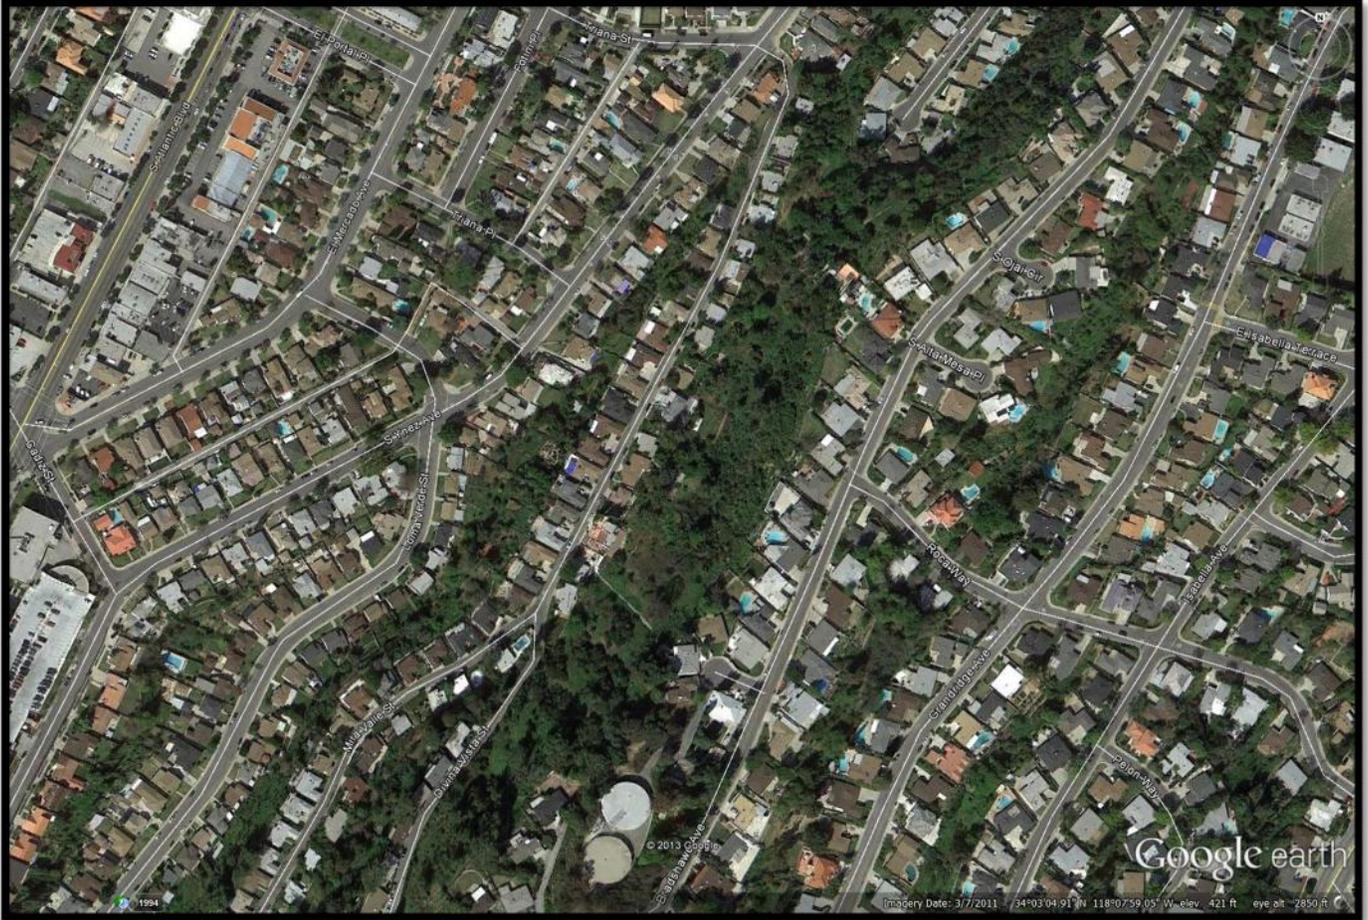
Capital Improvement Project Number	11 – 1996 Master Plan
Schedule	Year 8
Description/Location	Divina Vista Street: from Ynez Ave. to top of hill
Issue	Hydraulic Deficiency
Budget	\$110,200
➤ Design	\$18,400
➤ Construction	\$91,800

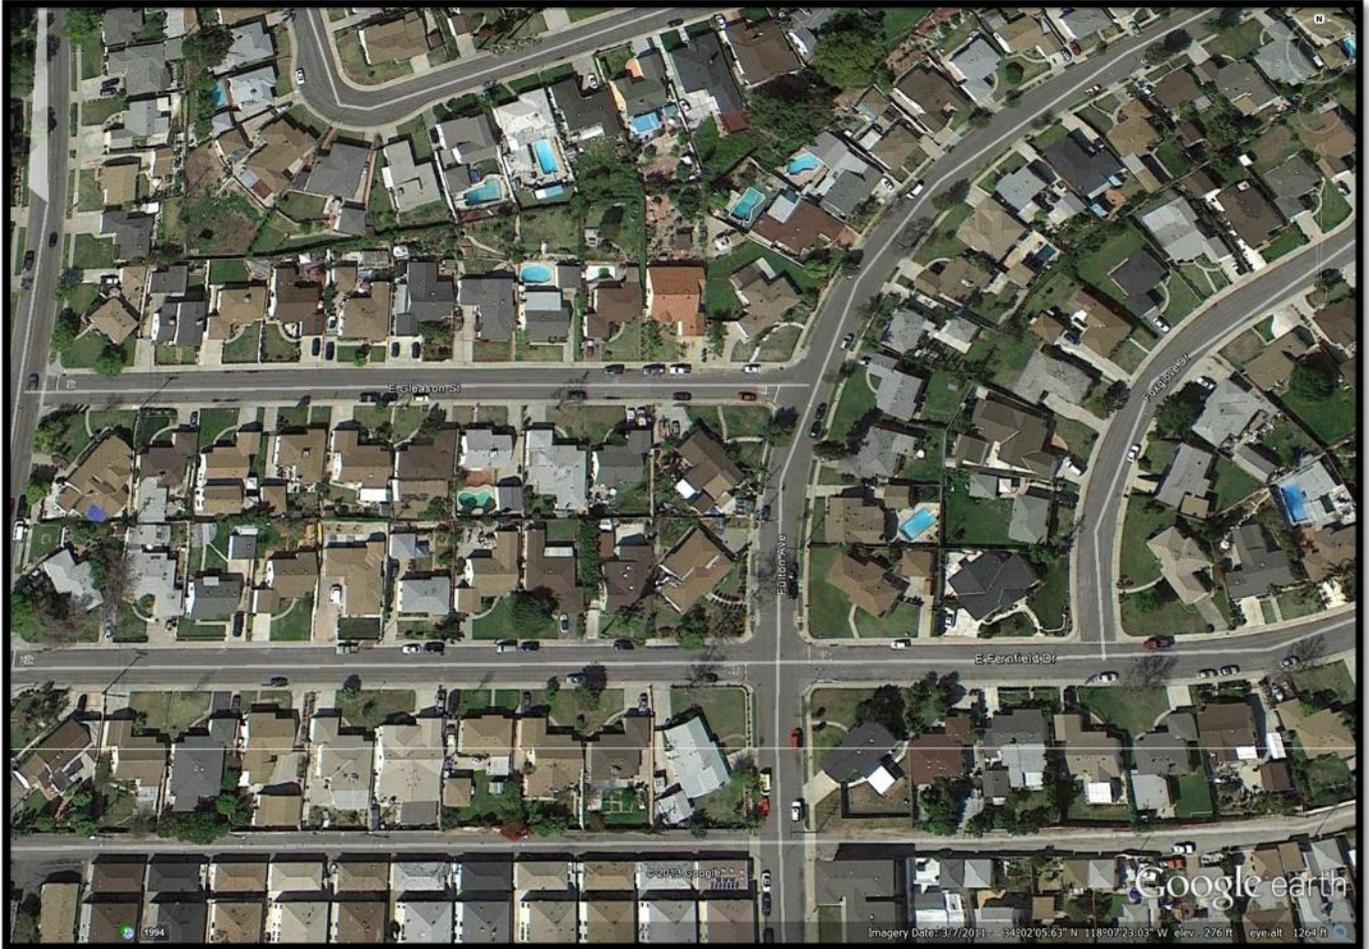
Capital Improvement Project Number	12 – 1996 Master Plan
Schedule	Year 9
Description/Location	Fulton Ave: from Fernfield Dr. to Gleason St.
Issue	Hydraulic Deficiency
Budget	\$111,100
➤ Design	\$18,500
➤ Construction	\$96,600
