City of Monterey Park Wastewater Collection System Master Plan Update

City of Monterey Park

Phoenix Civil Engineering, Inc.

1/13/2014

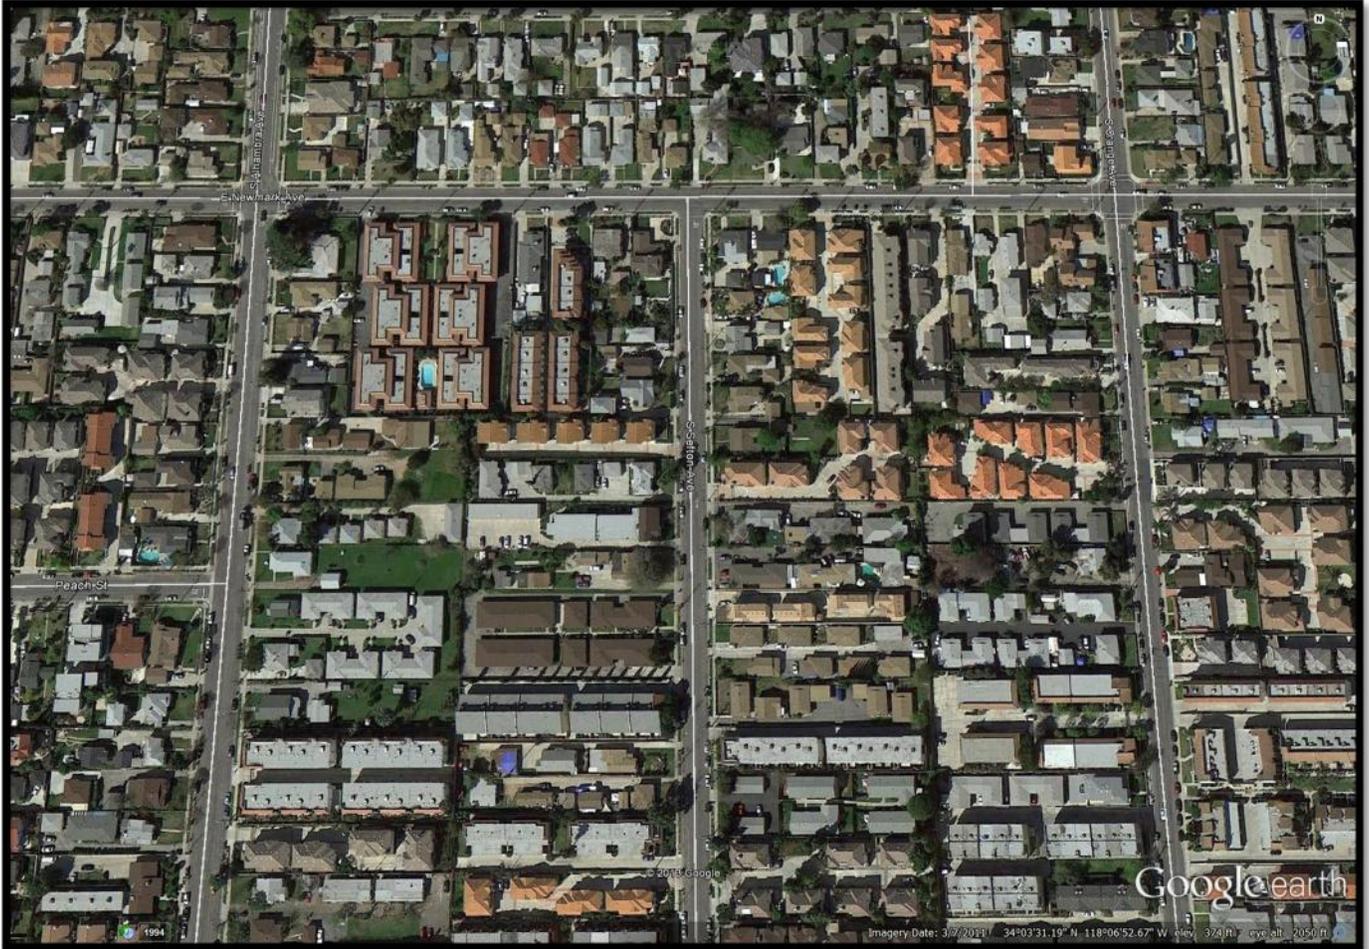
Capital Improvement Project Number	13 – 1996 Master Plan
Schedule	Year 9
Description/Location	Sefton Avenue: from Newmark Ave. to 310 feet south
Issue	Hydraulic Deficiency
Budget	\$112,700
➤ Design	\$18,800
➤ Construction	\$93,900

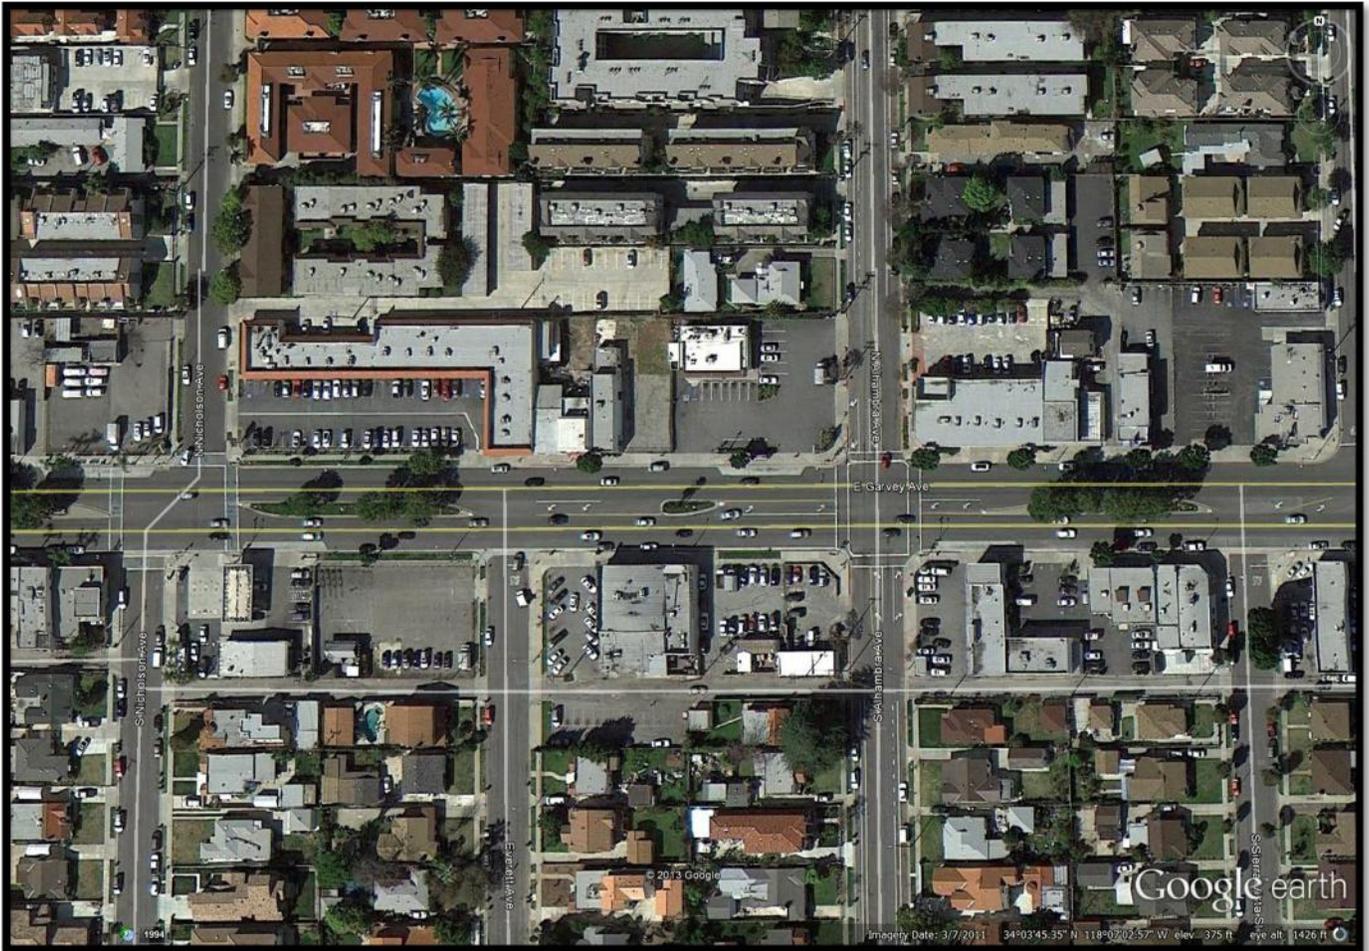
Capital Improvement Project Number	14 – 1996 Master Plan
Schedule	Year 9
Description/Location	Garvey Ave.: from Alhambra Ave. to Nicholson Ave.
Issue	Hydraulic Deficiency
Budget	\$205,600
➤ Design	\$34,300
➤ Construction	\$171,300

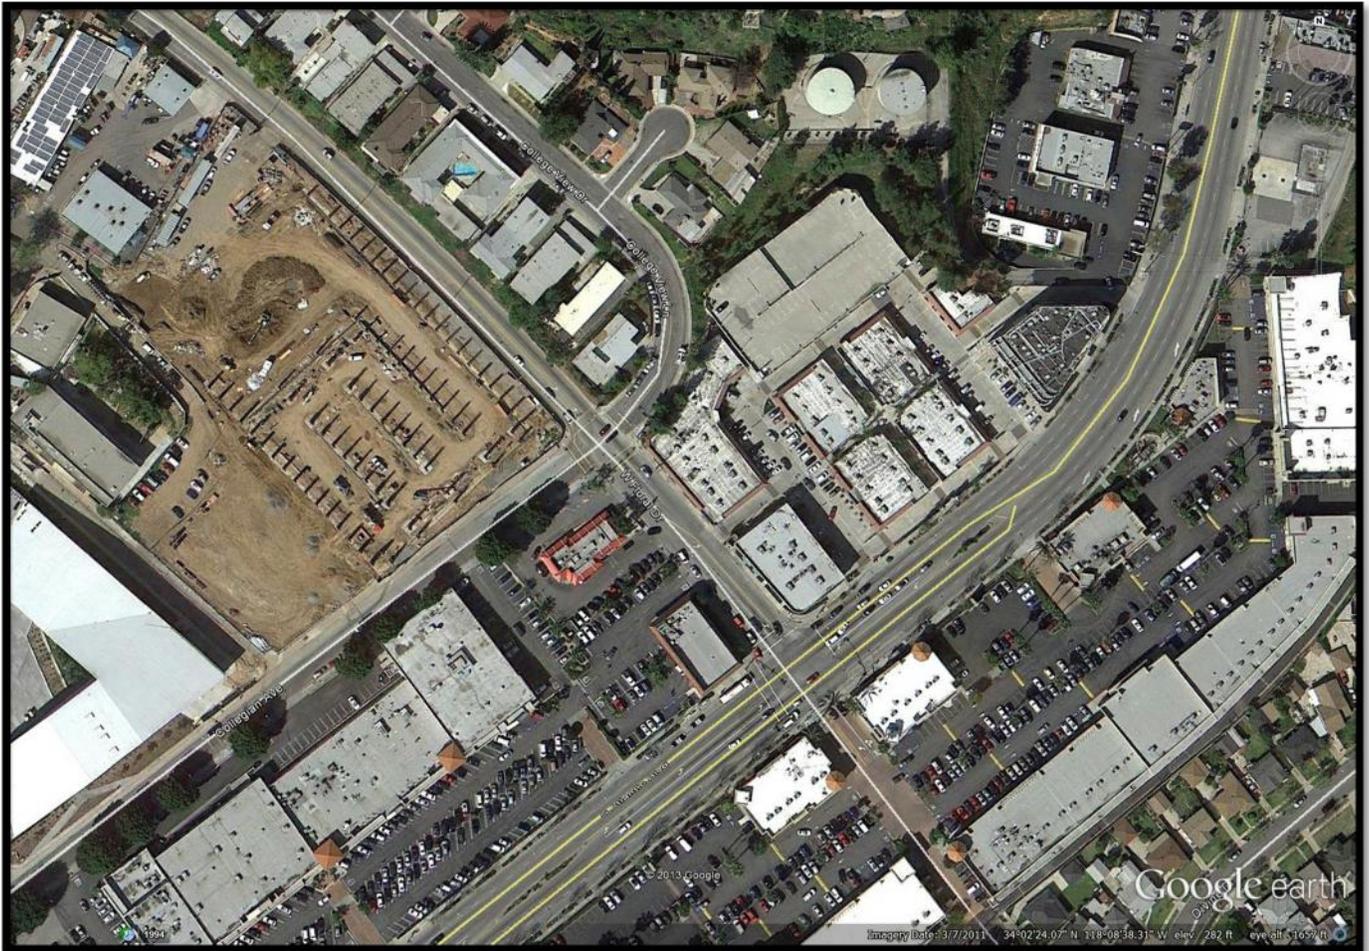
Capital Improvement Project Number	15 – 1996 Master Plan
Schedule	Year 10
Description/Location	Floral Drive: from Atlantic Blvd. to Collegian Ave.
Issue	Hydraulic Deficiency
Budget	\$78,800
➤ Design	\$13,100
➤ Construction	\$65,700

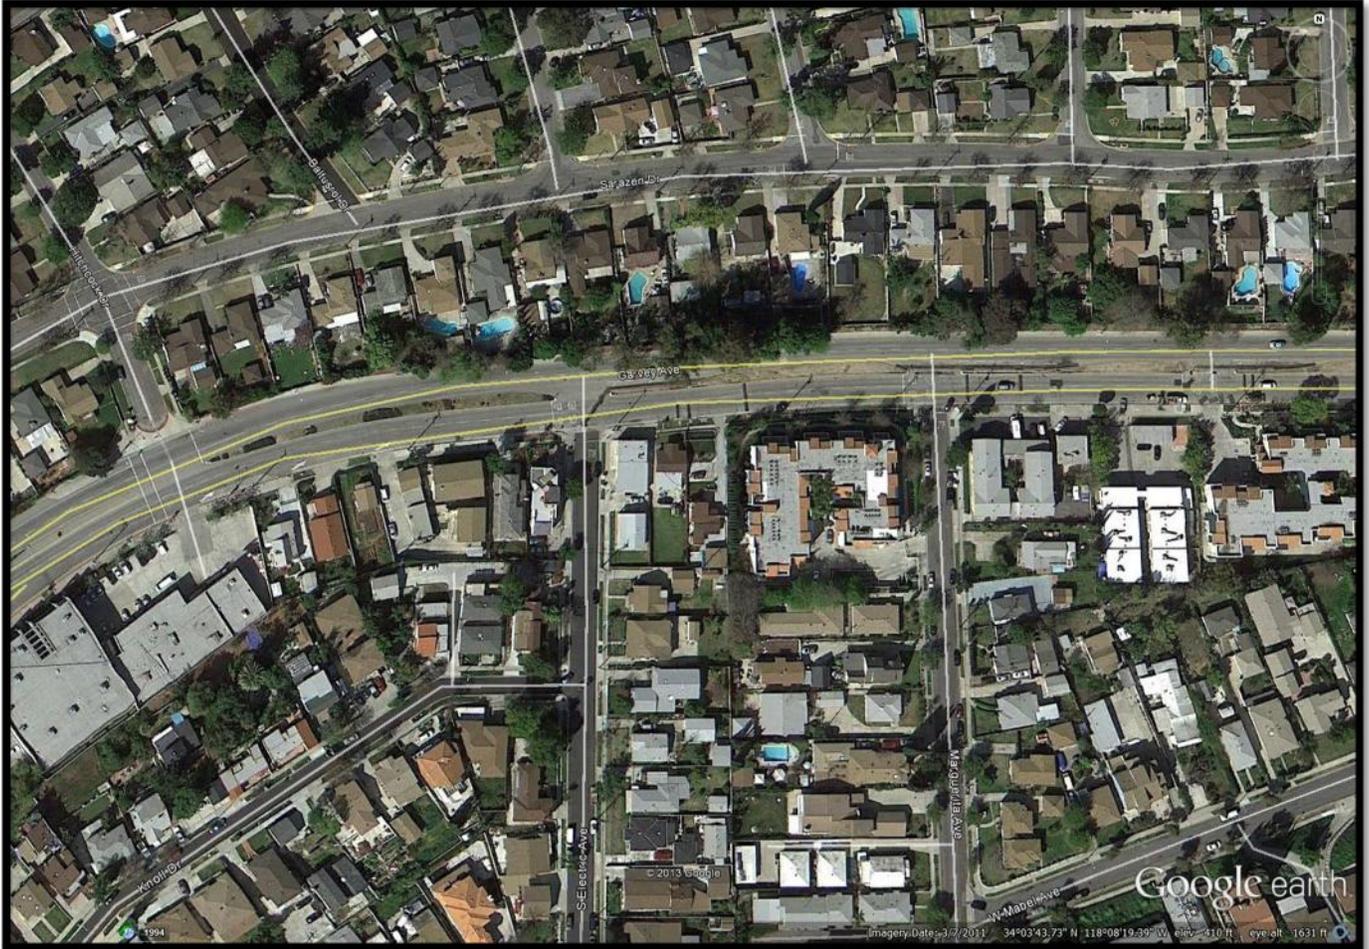
Capital Improvement Project Number	16 – 1996 Master Plan
Schedule	Year 10
Description/Location	Garvey Ave.: from Electric Ave. to Marguerita Ave.
Issue	Hydraulic Deficiency
Budget	\$128,800
➤ Design	\$21,500
➤ Construction	\$107,300

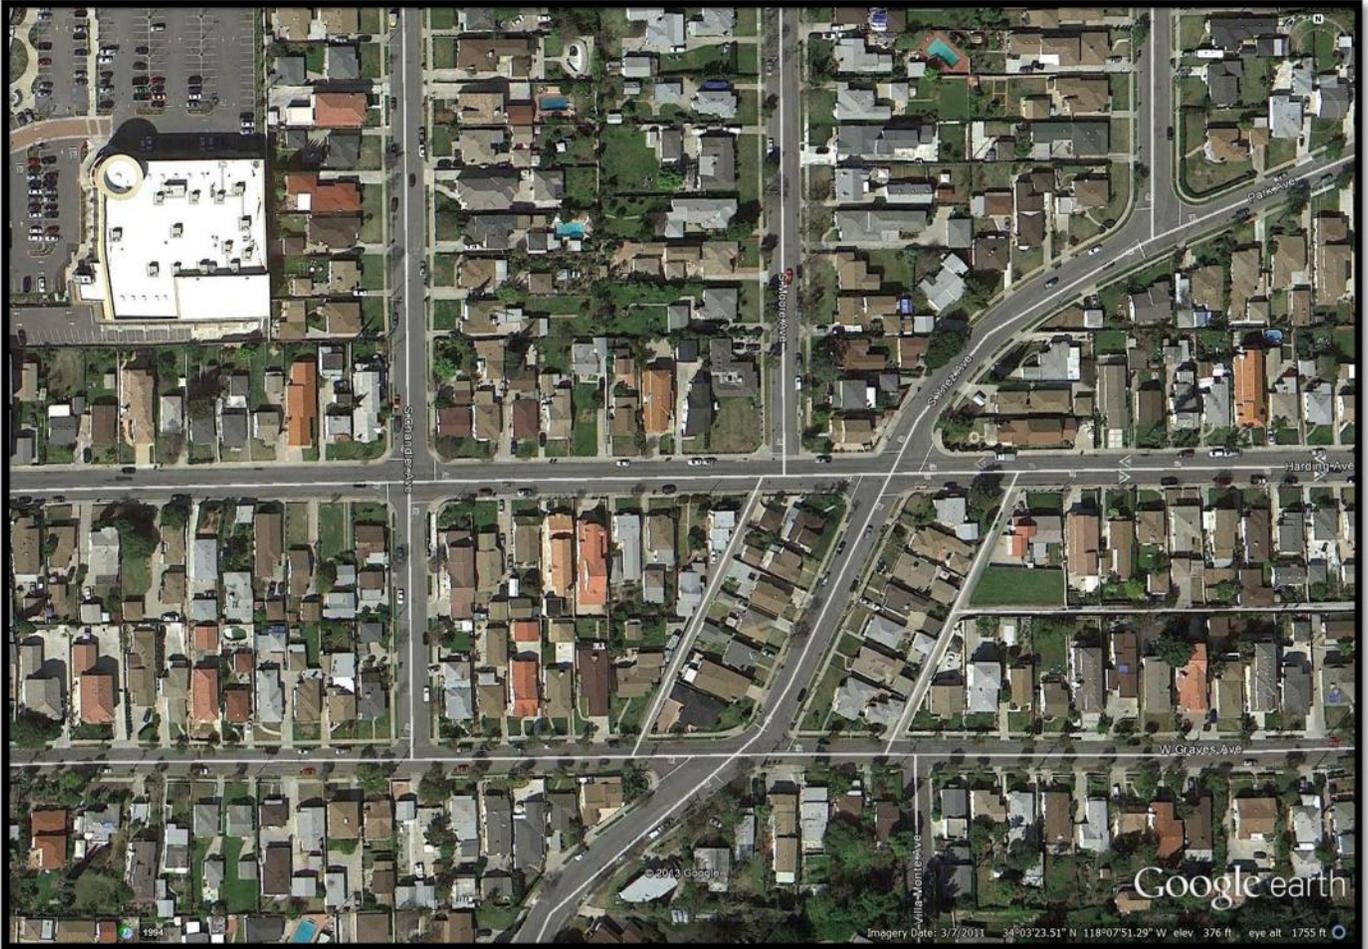
Capital Improvement Project Number	17 – 1996 Master Plan
Schedule	Year 10
Description/Location	Harding Ave.: from Ynez Ave. to Chandler Ave.
Issue	Hydraulic Deficiency
Budget	\$199,100
➤ Design	\$33,200
➤ Construction	\$165,900

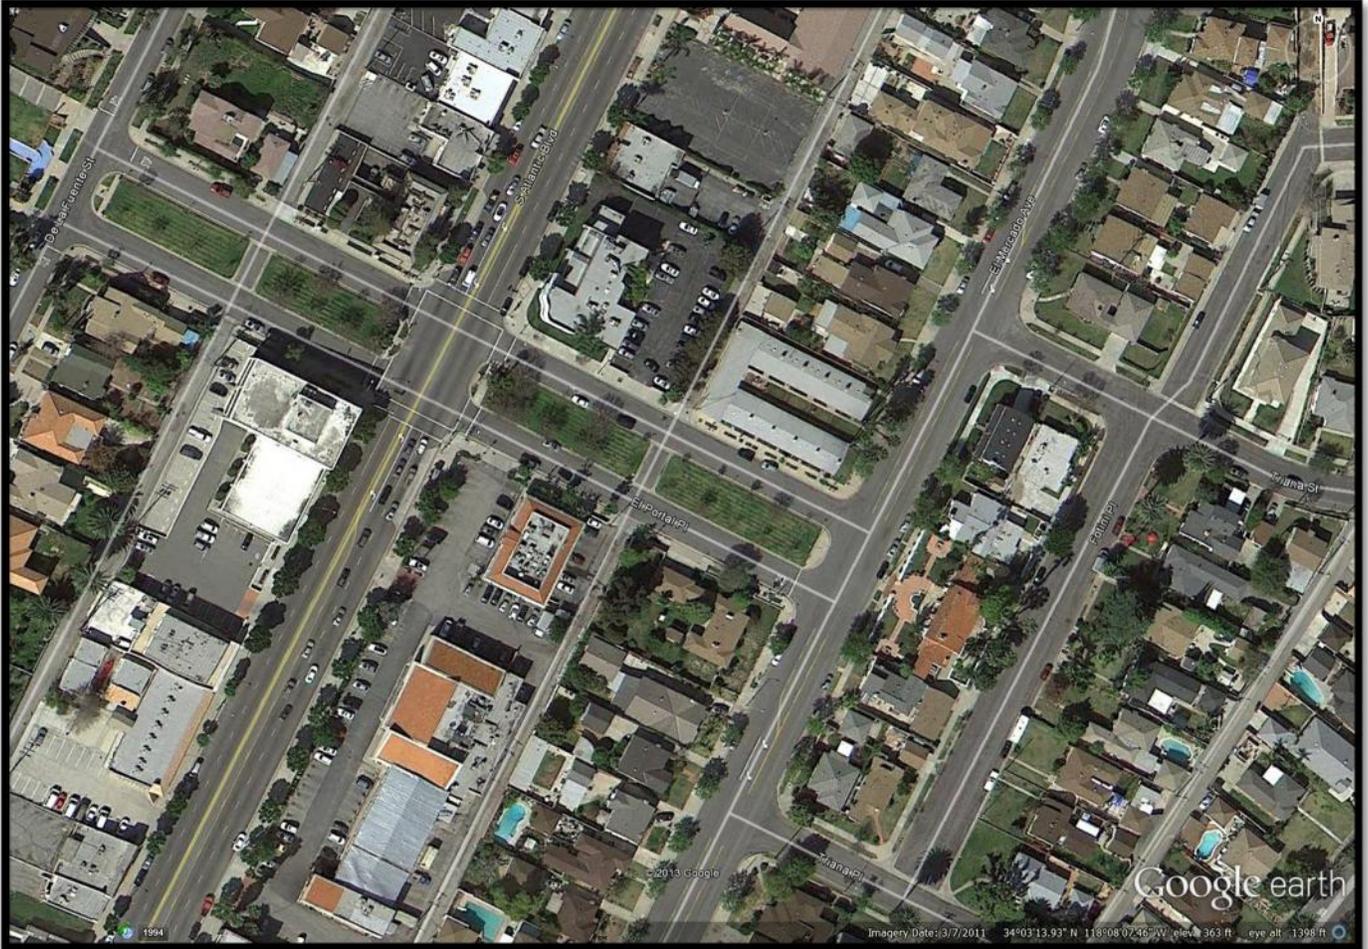
Capital Improvement Project Number	18 – 1996 Master Plan
Schedule	Year 10
Description/Location	Easement north of El Portal Pl.: from Atlantic Blvd. to Alley west of Atlantic Blvd.
Issue	Hydraulic Deficiency
Budget	\$73,800
➤ Design	\$12,300
➤ Construction	\$61,500

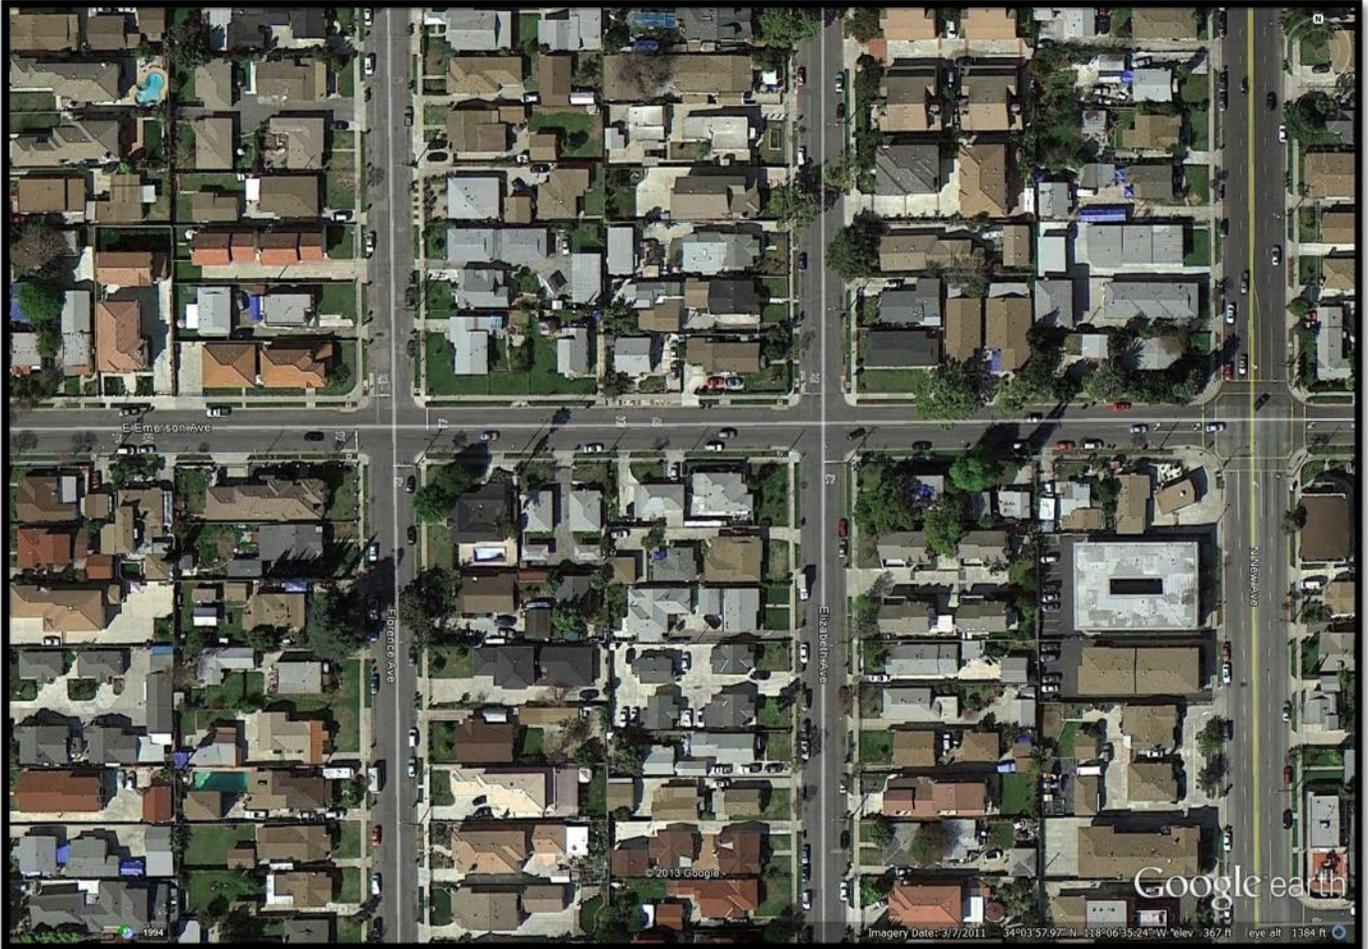
Capital Improvement Project Number	19 – 1996 Master Plan
Schedule	Year 10
Description/Location	Emerson Ave.: from Elizabeth Ave. to 200 feet west
Issue	Hydraulic Deficiency
Budget	\$88,000
➤ Design	\$14,700
➤ Construction	\$73,300

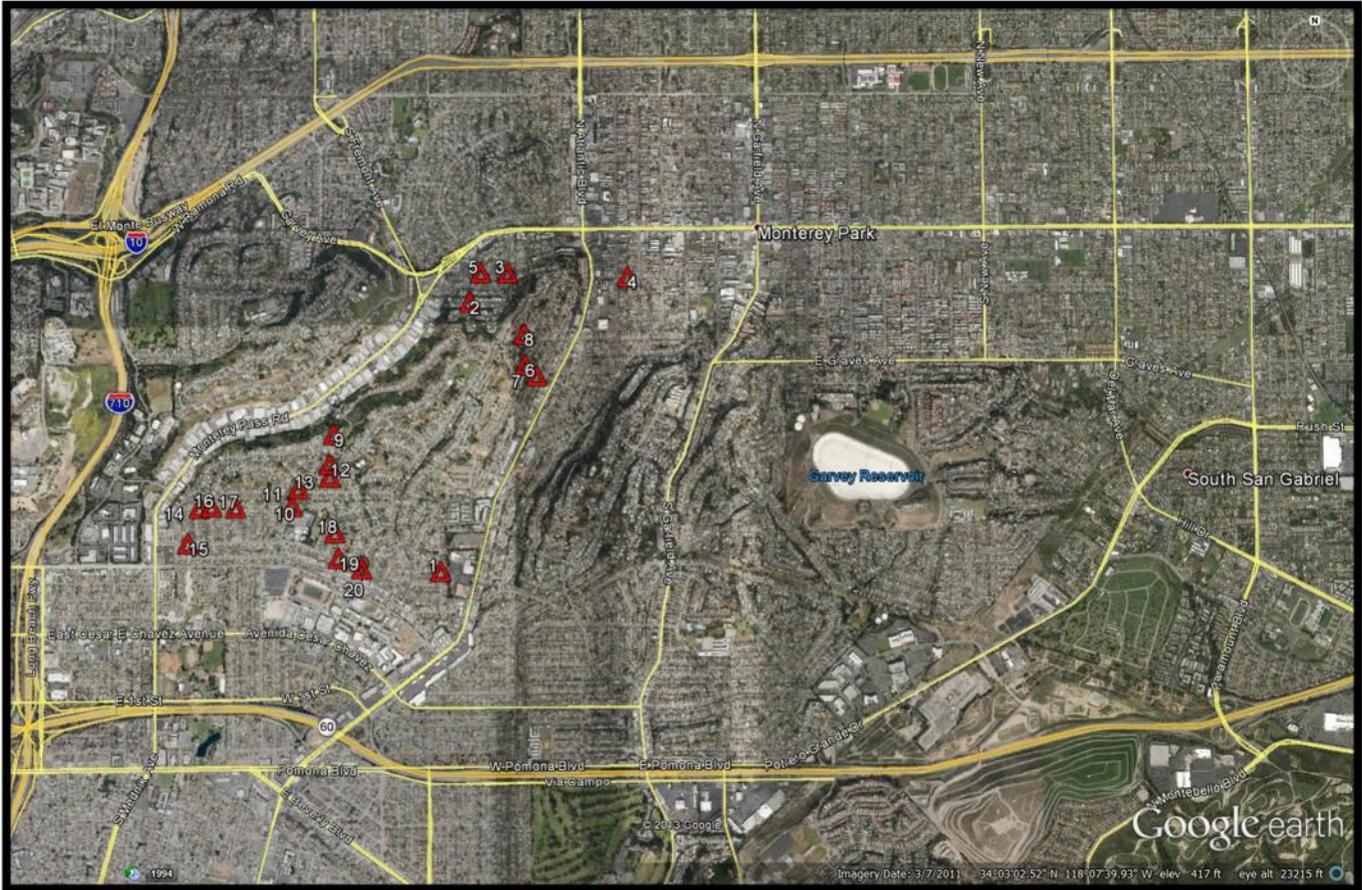
Capital Improvement Project Number	22 – 2013 CCTV Review
Schedule	Year 2
Description/Location	Spot Repairs - Multiple Locations
Issue	Pipeline Structural Deficiency
Budget	\$365,000
➤ Design	\$60,800
➤ Construction	\$304,200

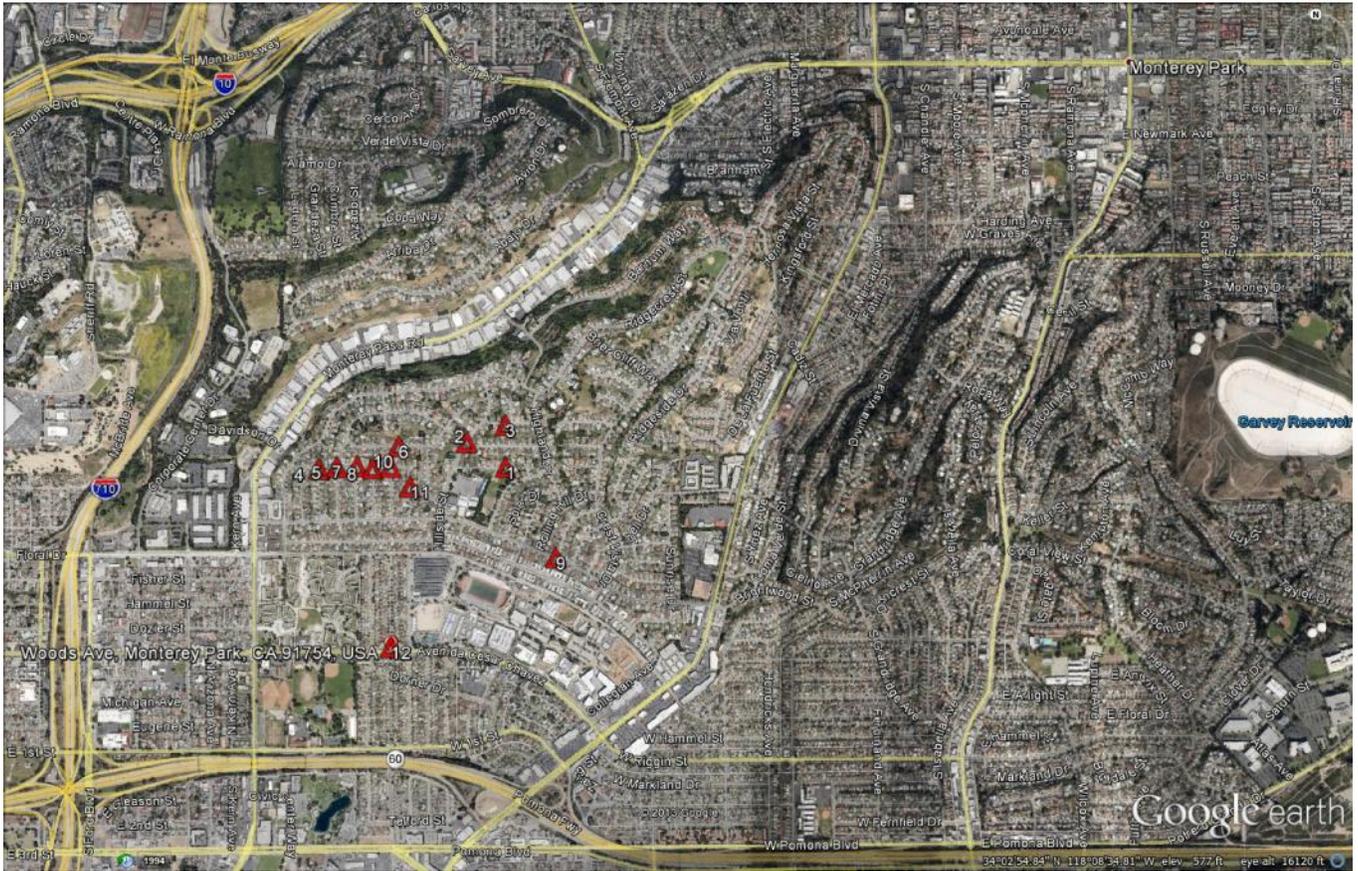
Capital Improvement Project Number	26 – 2013 CCTV Review
Schedule	Year 2
Description/Location	Cured in Place Pipe Installations - Multiple Locations
Issue	Pipeline Structural Deficiency
Budget	\$570,400
➤ Design	\$95,100
➤ Construction	\$475,300

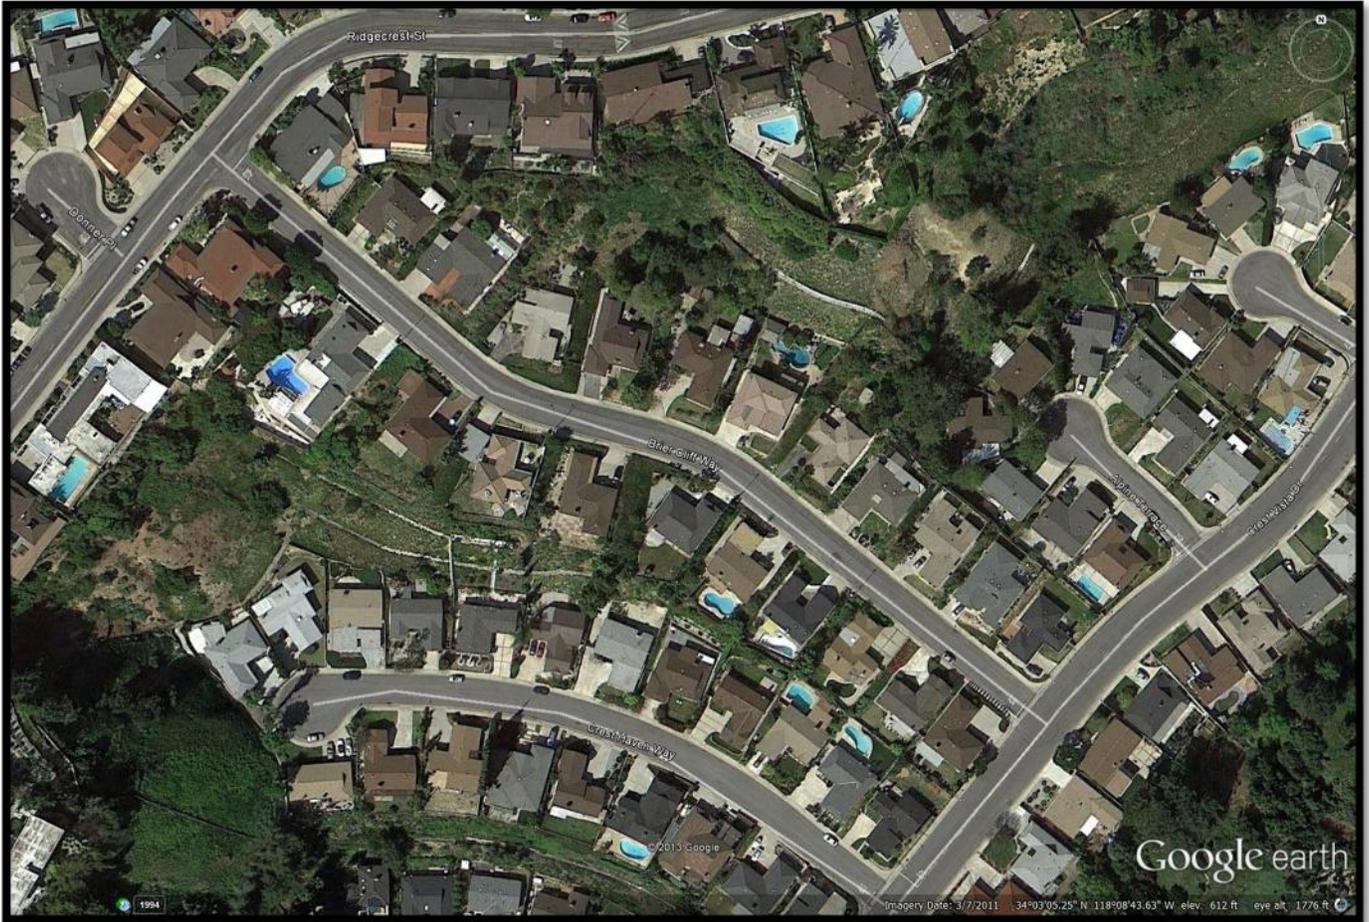
Capital Improvement Project Number	31 – 2013 CCTV Review
Schedule	Year 1
Description/Location	Briar Cliff Way
Issue	Pipeline Structural Deficiency
Budget	\$67,200.00
➤ Design	\$11,200
➤ Construction	\$56,000

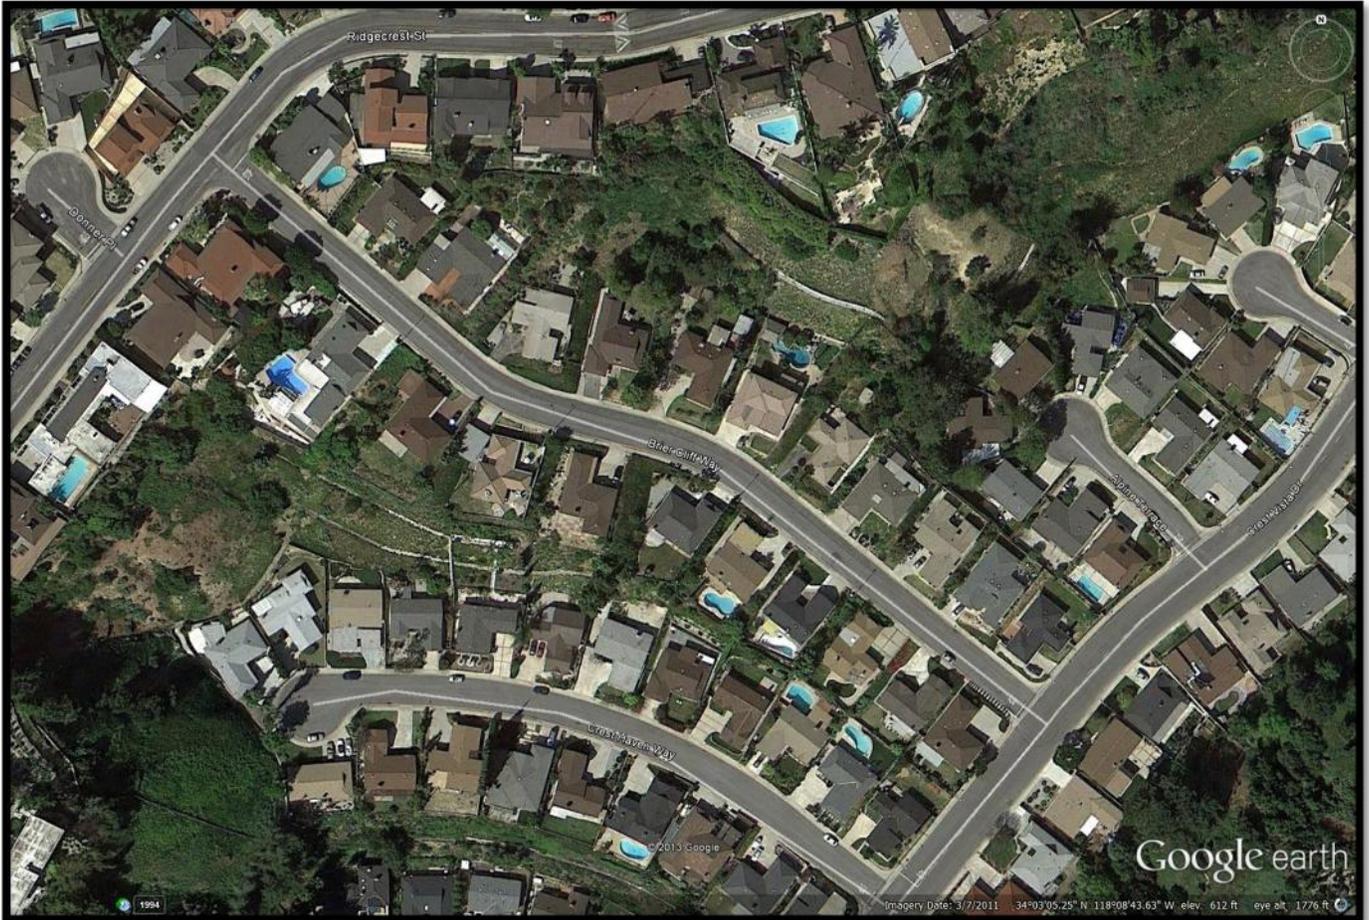
Capital Improvement Project Number	32 – 2013 CCTV Review
Schedule	Year 1
Description/Location	Alpine Terrace
Issue	Pipeline Structural Deficiency
Budget	\$96,700
➤ Design	\$16,100
➤ Construction	\$80,600
